BOARD OF INQUIRY REPORT

298 BEACON STREET
BOSTON, MASSACHUSETTS

INCIDENT # 14-16454

Report on: The Line-of-Duty Fatal Fire on March 26, 2014
298 Beacon Street Boston, Massachusetts
District 4, Division 1
Incident # 16454 Box 9-1579

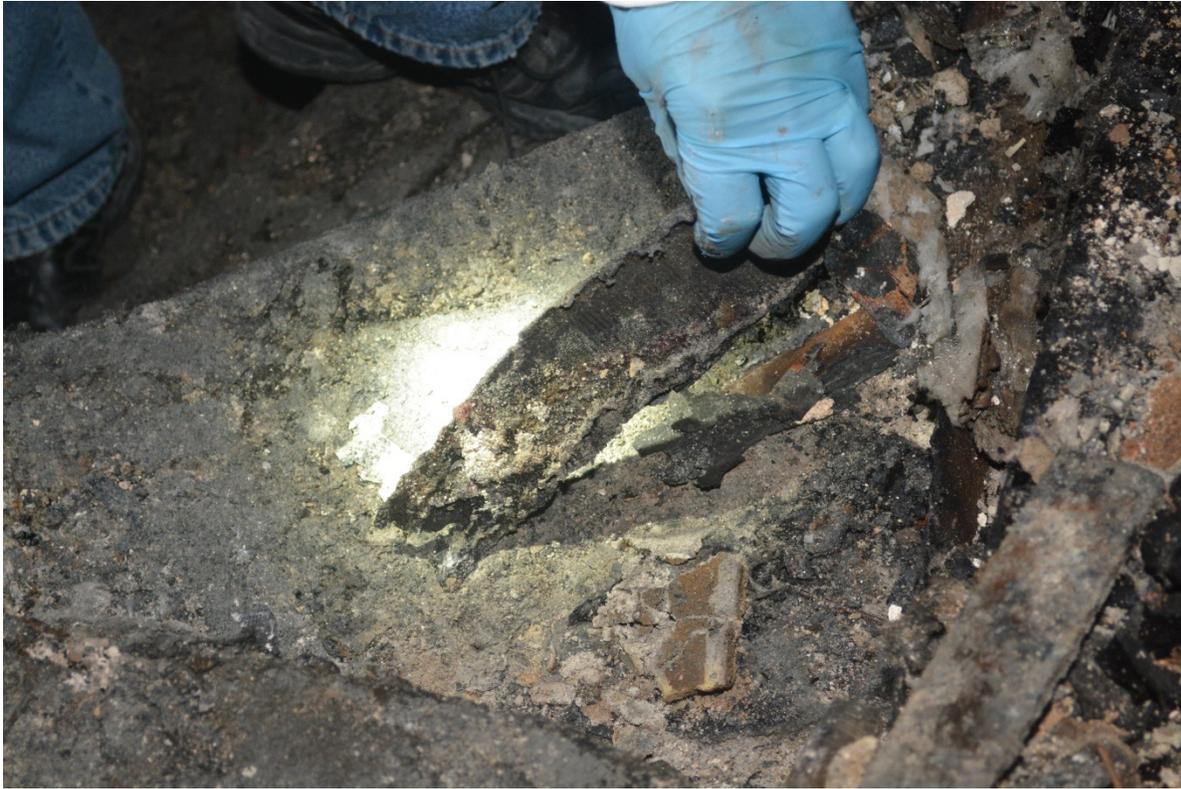
Engine 33 requested that their line be charged at approximately 14:48:48. E33 repeated this request several times over the next five minutes. Members of E07, E22 and E37 stated that they saw E33's line charged despite repeated requests by E33's Officer to charge the line. One Firefighter from L15, operating independently, advanced into the front entryway. He stated that the water on the floor was hot and that he was getting soaked. He thought it was an open line but found a "canoed" 1 3/4 inch line of hose with water coming out of it.

Section of a "canoed" hose found at the top of the stairs after the fire

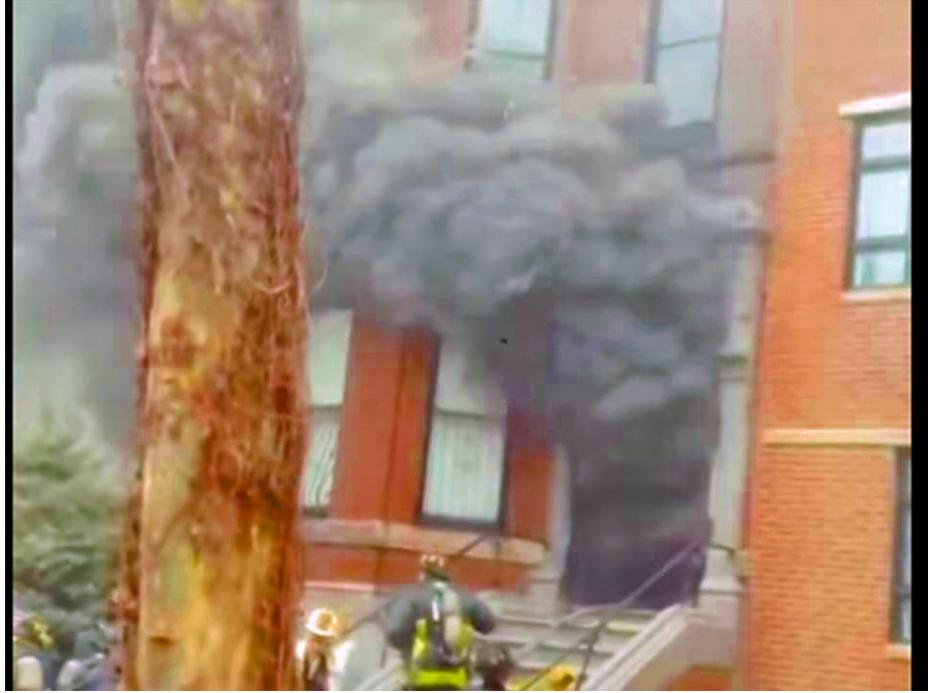
Figure IX-3. Smoke venting through front doorway at approximately 14:50.

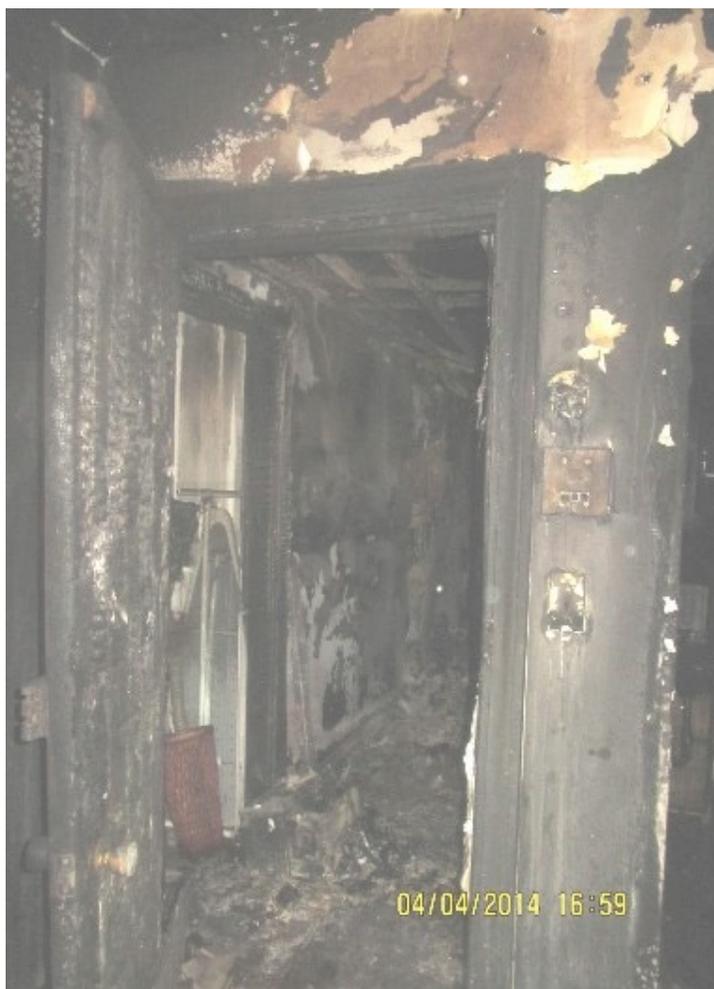
Upon touching this door, he felt significant heat and heard a crackling sound coming from the other side of the doorway. This indicates that the basement hallway hot gases and possibly flame had spread to, and were accumulating, in the portion of the rear hallway (and likely above the ceiling void space) leading to the front apartment. The firefighter did not open the door and reported this information to the Incident Commander. Figure IX-5 shows the charred door (which was not opened until after the fire) and entrance to the hallway, and Figure IX-6 shows the door location in the basement. Combustibles burning in that section of the hallway included exposed electrical cables connected to the electrical meters, a wood dresser near the meters, an ironing board and storage bins containing Christmas decorations and plastic kitchenware. Air for the combustion of these combustible materials reached the rear hallway driven by the strong winds that entered the basement from the north.

Figure IX-5. Basement front apartment doorway leading to hallway.

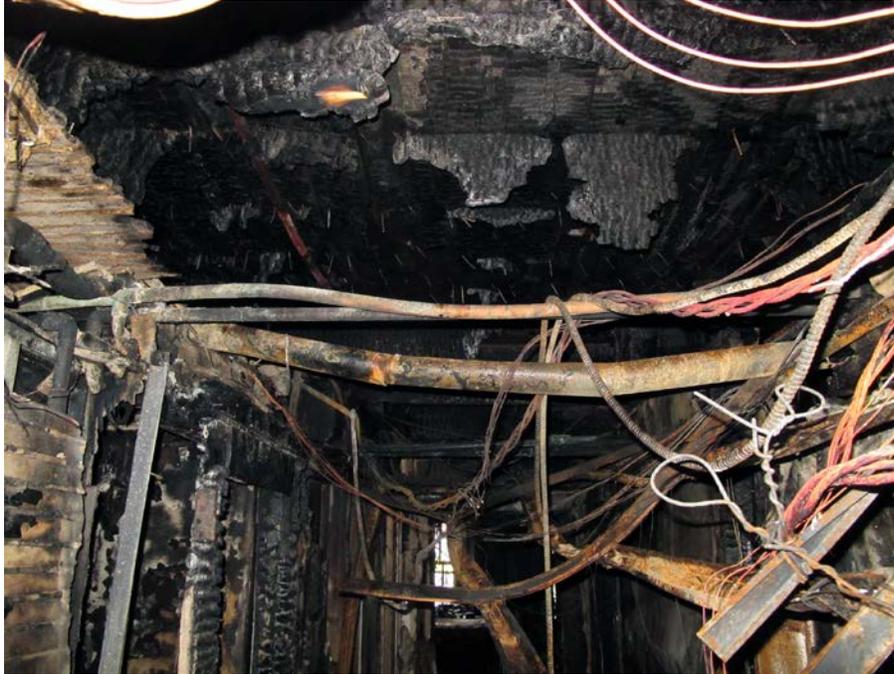
Investigators observed that the fire had destroyed the plaster-on-wood lath ceilings and walls, exposing many formerly hidden vertical and horizontal void spaces. This was most noticeable in the basement exit hallway where there was no visible fire stopping in the joist bays above the original plaster ceiling between the hallway and the adjoining apartment. Also noted above the hallway's suspended gypsum drywall ceiling was a large open vertical shaft from the basement ceiling to the underside of the second floor. The shaft contained a large cylindrical heating duct that was abandoned in place when the heating system was converted to a forced hot water system. Although the preexisting plaster wall/ceiling assembly may have been adequate to contain a fire within the hallway from extending to the adjoining apartment, the lack of horizontal and vertical fire stopping above the ceiling likely allowed fire to travel unimpeded in the combustible joist bays once it extended into this space.

Figure IX-7. Burned joists and wiring above basement hallway ceiling.

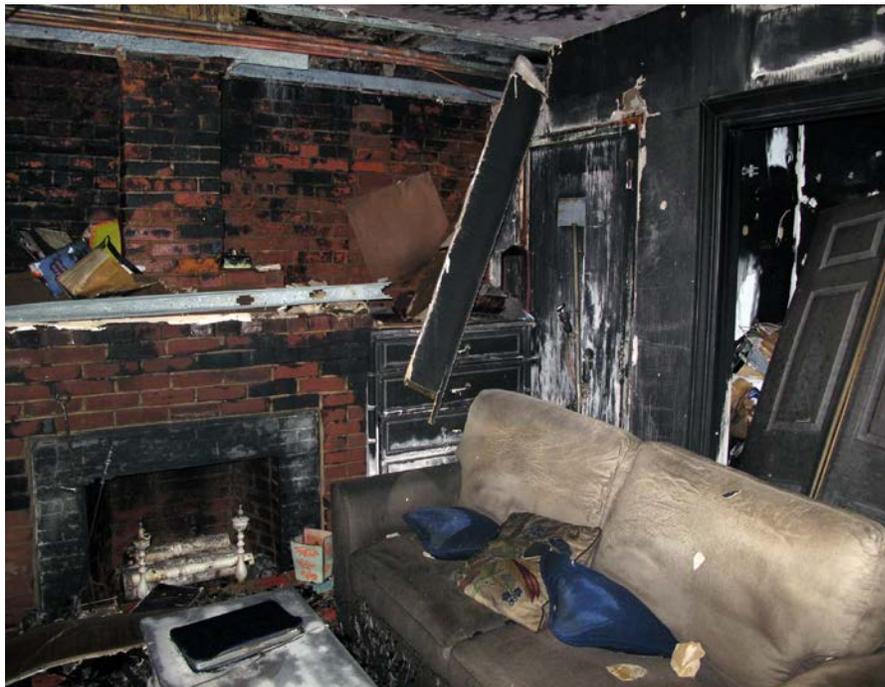
The hot combustion gases above the basement ceiling apparently flowed all the way to the front basement apartment where they descended into the apartment itself. When firefighters attempted to enter the front basement apartment shortly after 14:50, the extreme heat and combustion gases prevented entry. Views of the basement front apartment after the fire showed heavy charring at upper elevations but only minor burning of the combustible furniture below as seen in Figure X8.

Figure IX-8. Basement front apartment after fire.

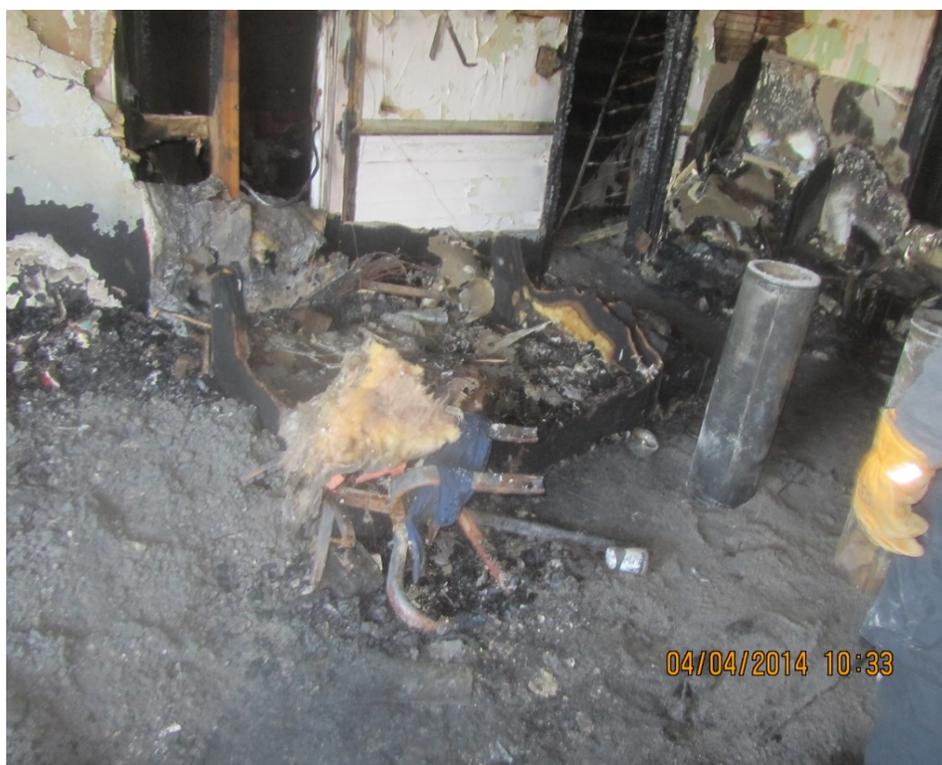
The hot gases entering the basement rear apartment accumulated in a deepening layer under the ceiling. Eventually radiation from the hot ceiling layer ignited the combustible furnishings in the apartment. These included window curtains and fabric blinds, paintings on the walls, a sofa, a bed with blanket and mattress, an area rug, a table and chairs. Views of the rear apartment after the fire showed that most of these furnishings were almost completely burned as indicated in Figure IX-9.

Figure IX-9. Remnants of basement rear apartment furnishing.

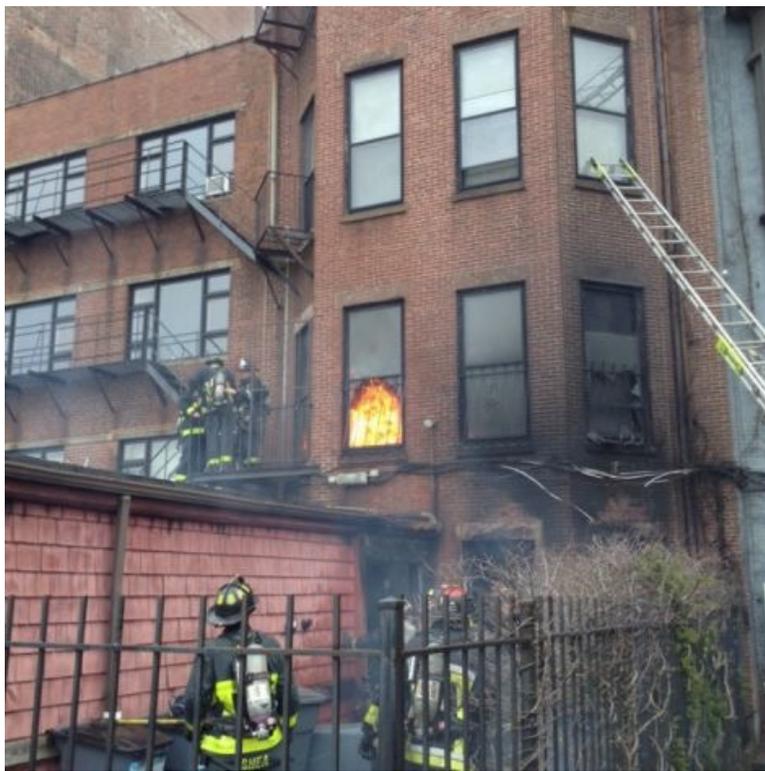
Hot gases from the basement hallway and rear apartment fires entered the first floor apartment rear living room via floor penetrations. Some flame also entered the apartment and may have ignited a ladder-back chair in front of a window, as shown in Figure IX-10. The lower half of the northwest window is also broken at this time but a large flat-screen TV in front of the window inhibited wind flow through the broken window.

Figure IX-10. Flame showing through first floor rear window at 15:09.

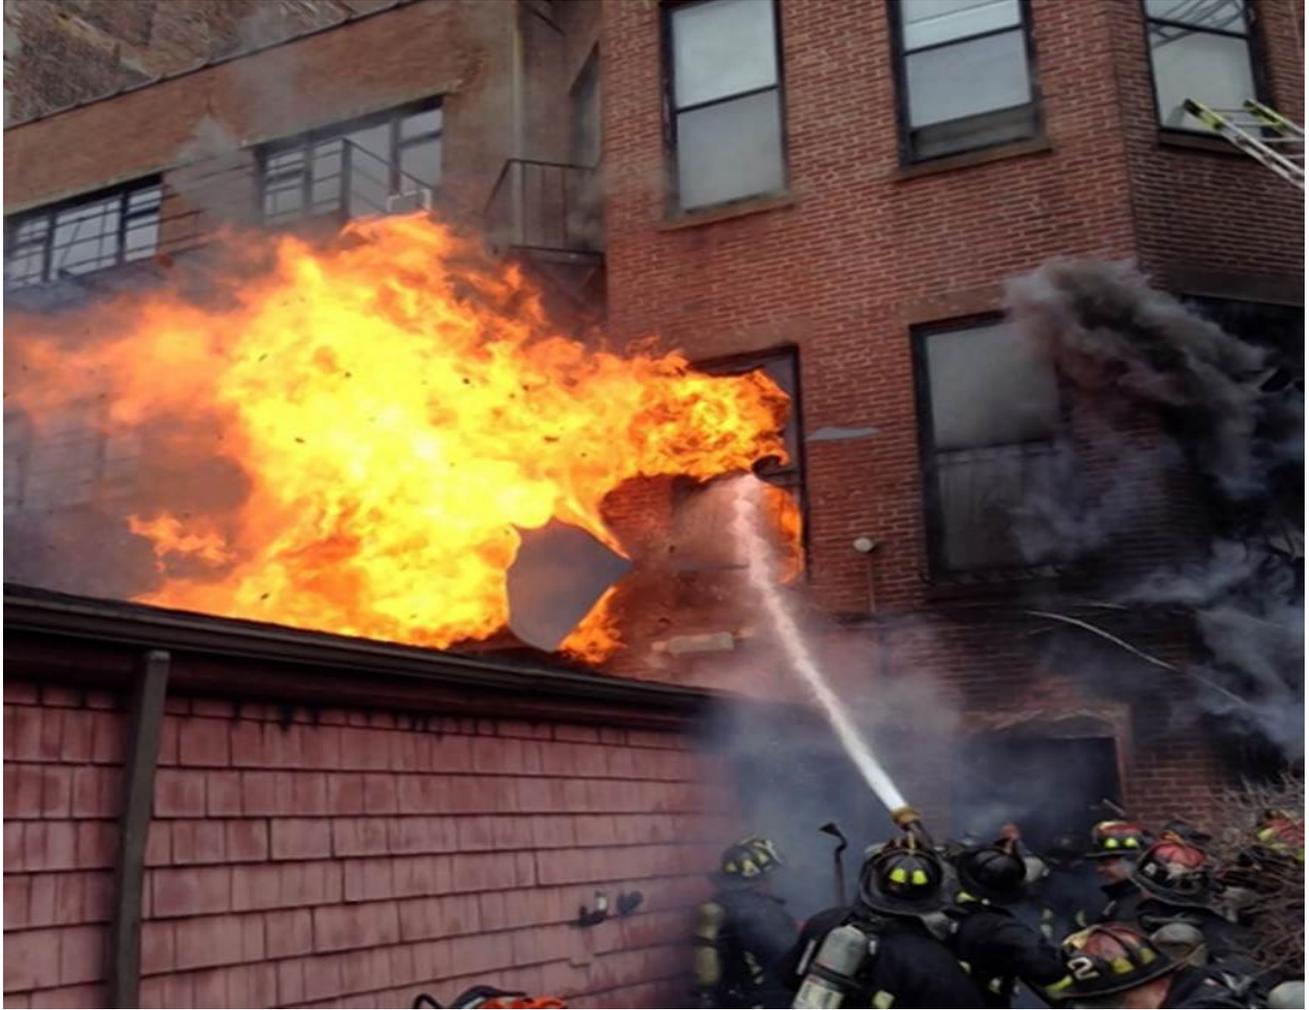
³ A smoke explosion differs from a backdraft explosion in that the latter requires a sudden change in ventilation, such as the opening of a door or window, which did not occur in this case. Reference: C. Fleishman and ZJ Chen, "Defining the difference between backdraft and smoke explosion," *Procedia Engineering* 62 (2013) 324 – 330.

Figure IX-11. Large projected flame and dark grey smoke from a smoke explosion at 15:11.

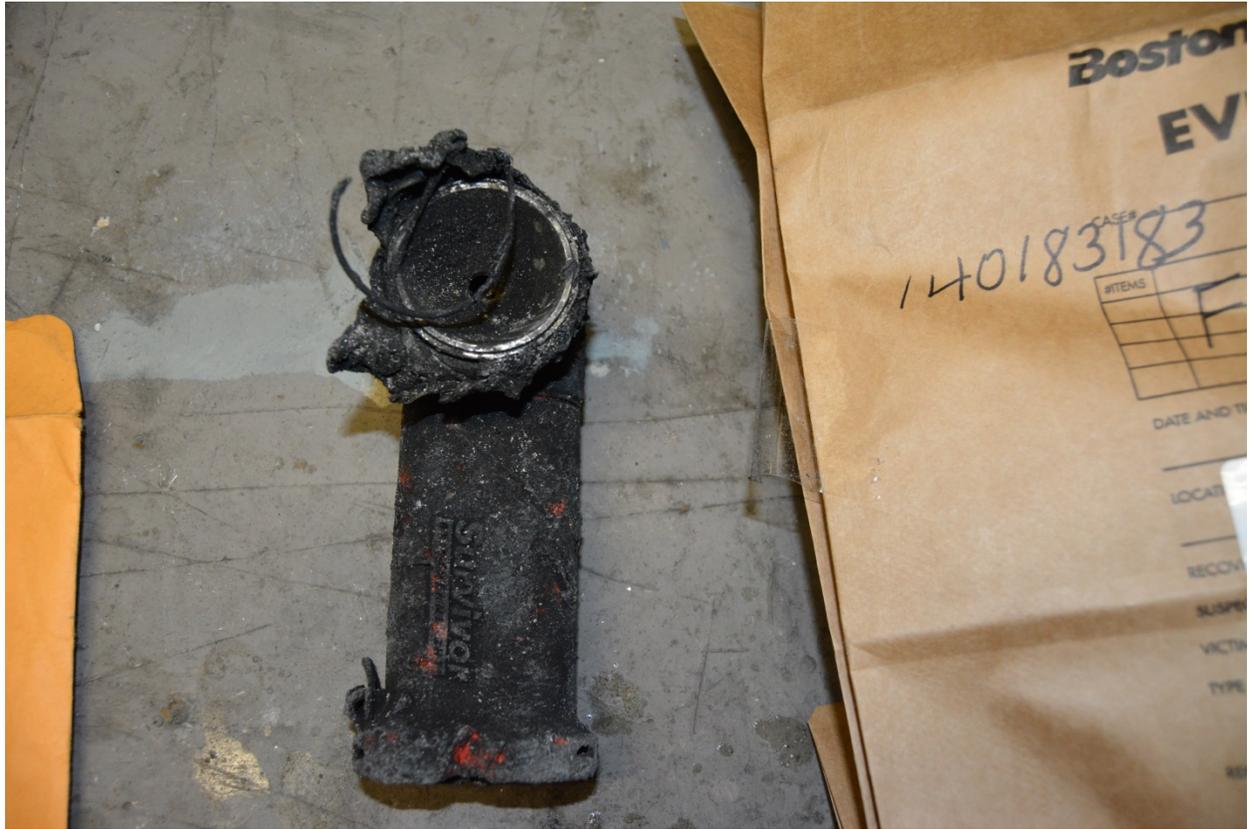
A Survivor flashlight was found to have minor thermal damage. The bezel was missing. The on/off button, when tested, still functioned properly. (Figure XI-23)

Figure XI-15. Lieutenant Walsh's Flashlight

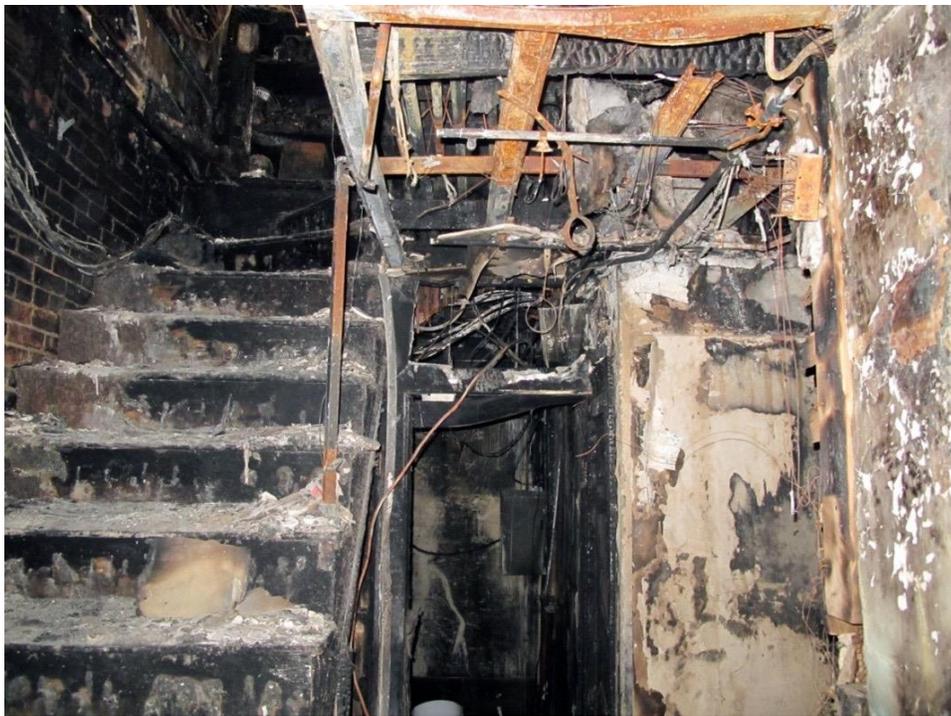
Figure XV-8 View from the bottom of the stairway showing the exposed framework for the suspended gypsum ceiling and the charred floor joists exposed after the plaster ceiling failed.

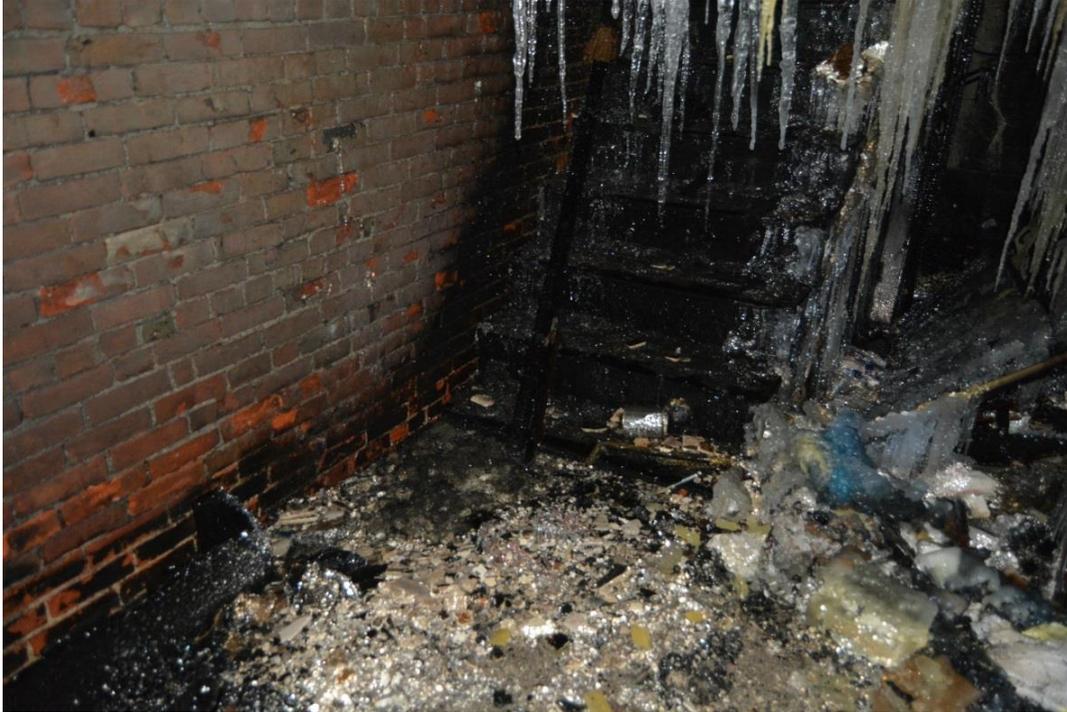
Figure XV-9 The foot of the basement stairs where LT Walsh was located. The door to the rear basement apartment is to the immediate right out of view.

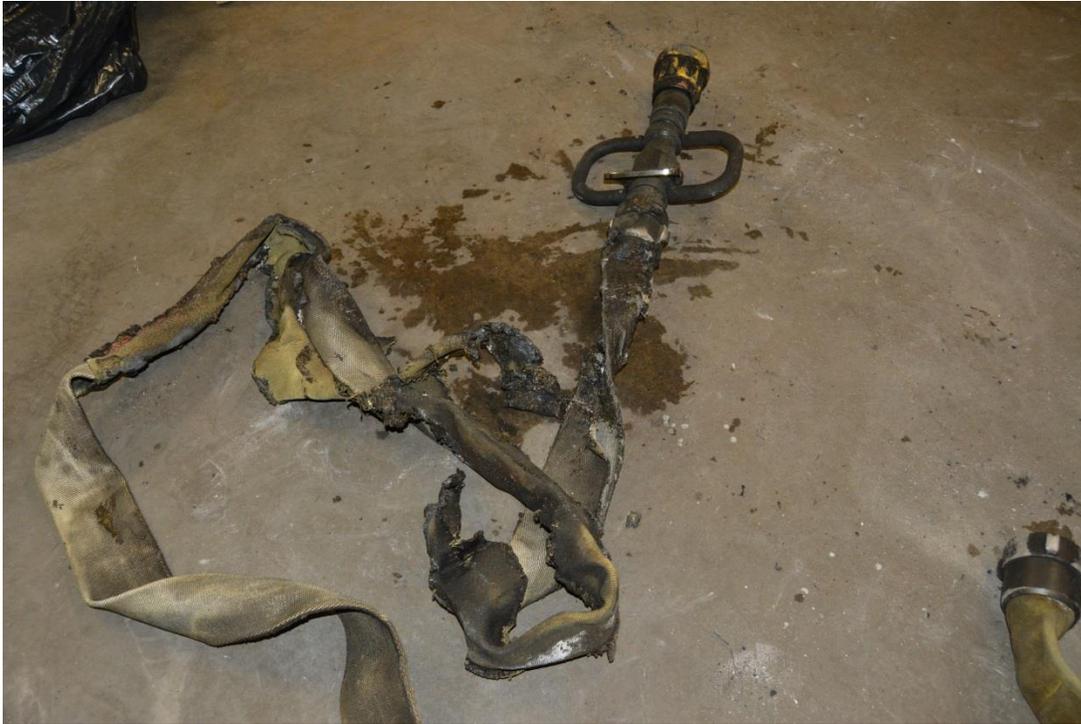
In the seconds it took to exit the twenty feet back out to the front exterior stairway, all of E07's Firefighters sustained first and second degree burns to their ears and exposed skin. Their uncharged 2 ½ inch line of hose, which had been dragged out behind them, was destroyed in the time it took to evacuate. (See figures XV27, XV28) The outer lining was charred away and the elastomeric bumper on the nozzle was distorted and melted from the heat.

Figure XV-27 E07's charred 2 ½ inch line of hose with the outer jacket burned away.

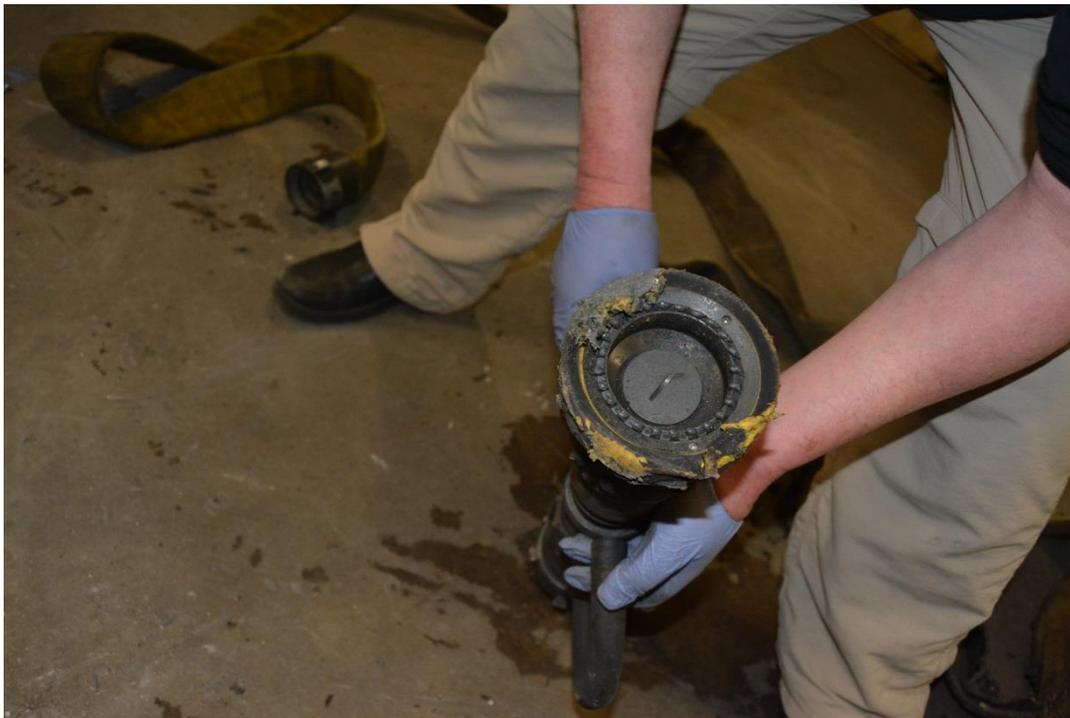
Figure XV-28 E07's nozzle with the elastomeric covering melted and distorted.

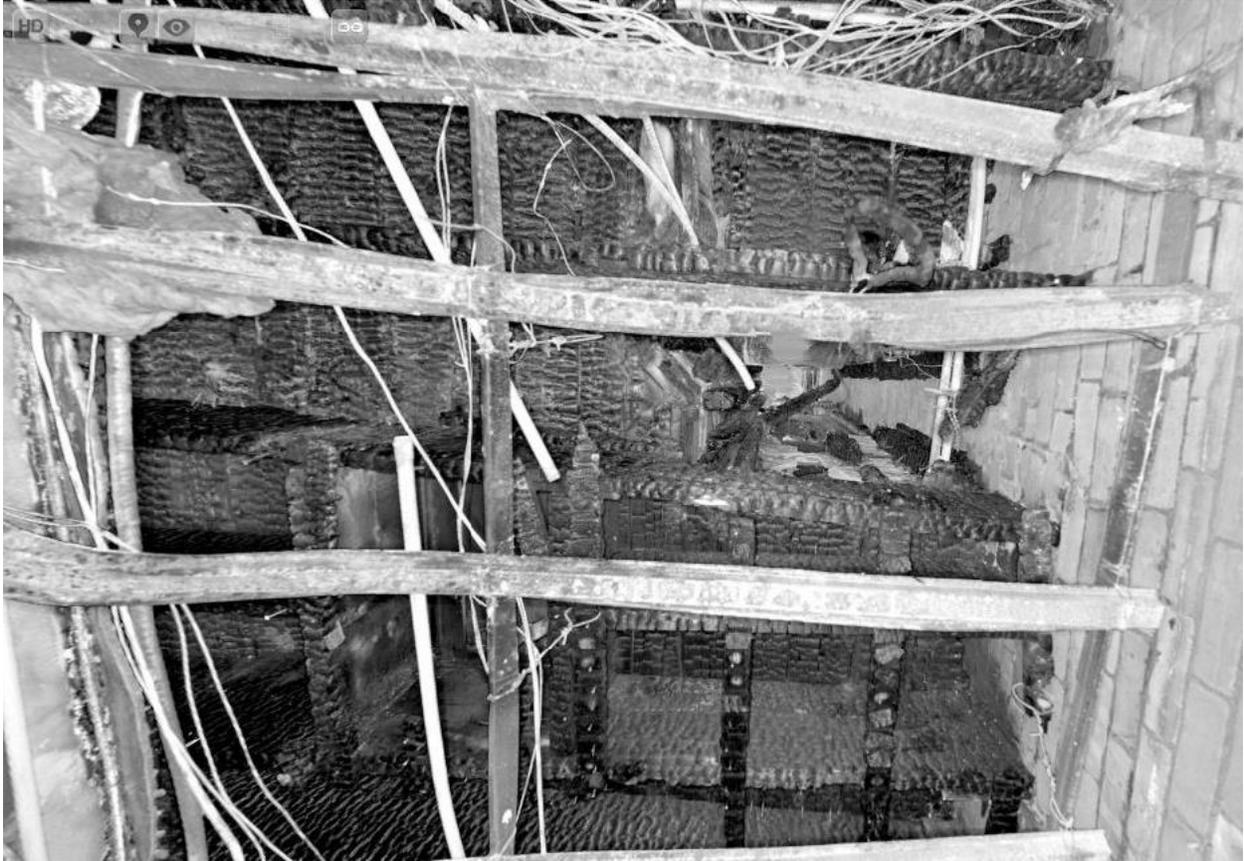
Figure XV-29 Two shafts above the ceiling viewed from the foot of the basement stairs.

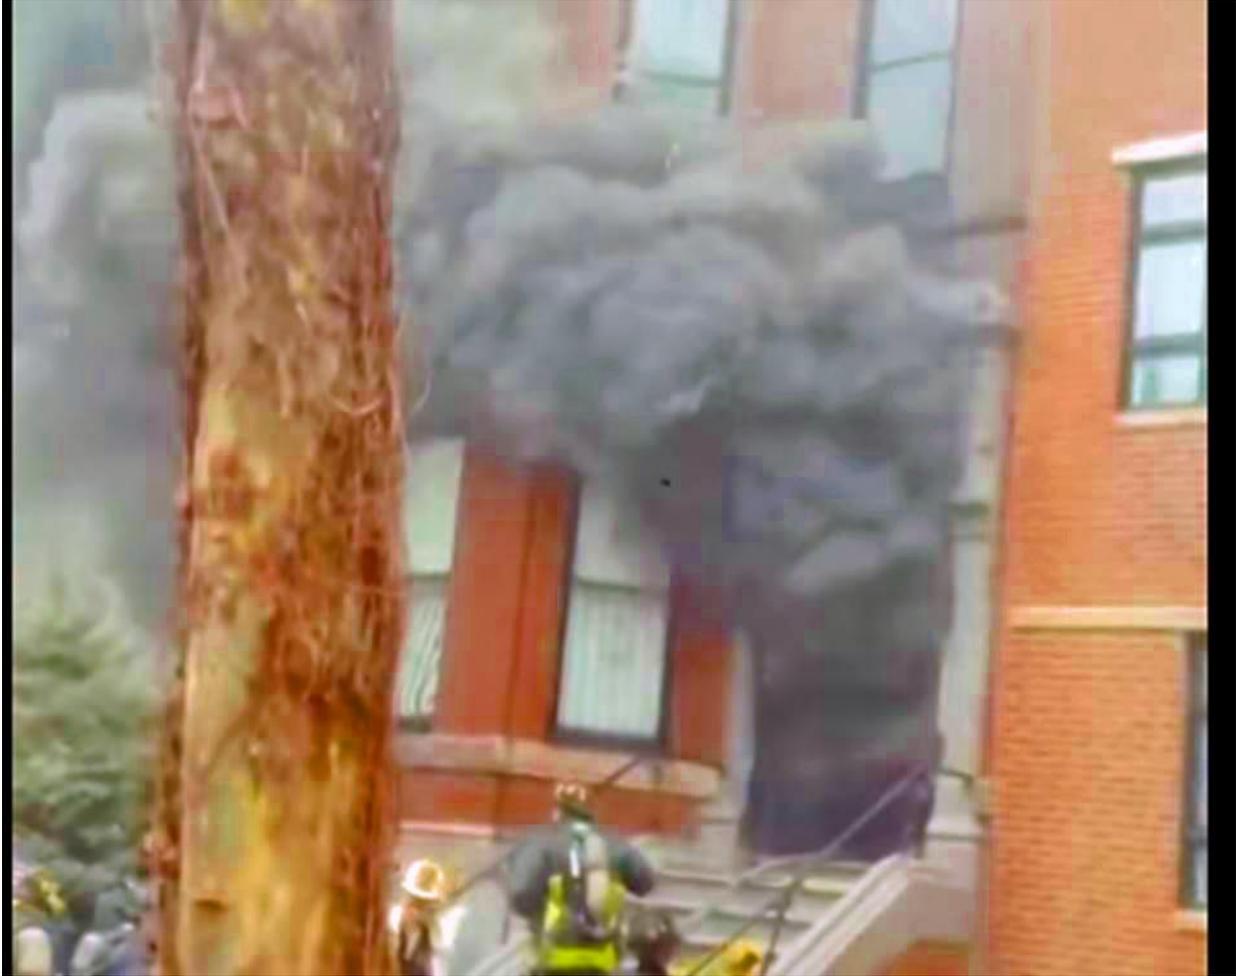
Figure XV-30 E33's 1 ¾ inch line of hose charged on the front stairs.
