## **Lieutenant and Fire Fighter Die and 13 Fire Fighters injured in a Wind-driven Fire in a Brownstone—Massachusetts**

### **Executive Summary**

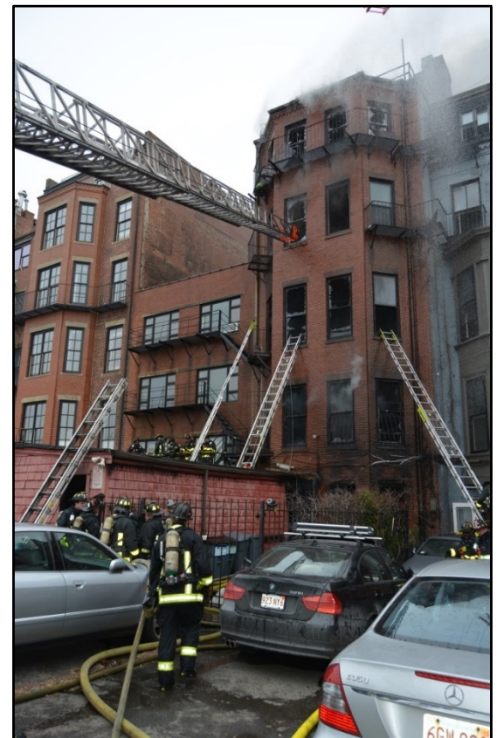
**A view of fireground from Side Charlie. The fire started near the one-story shed (located against the fence) and extended into hallway on the basement of the structure.**  
*(Photo courtesy of the fire department)*

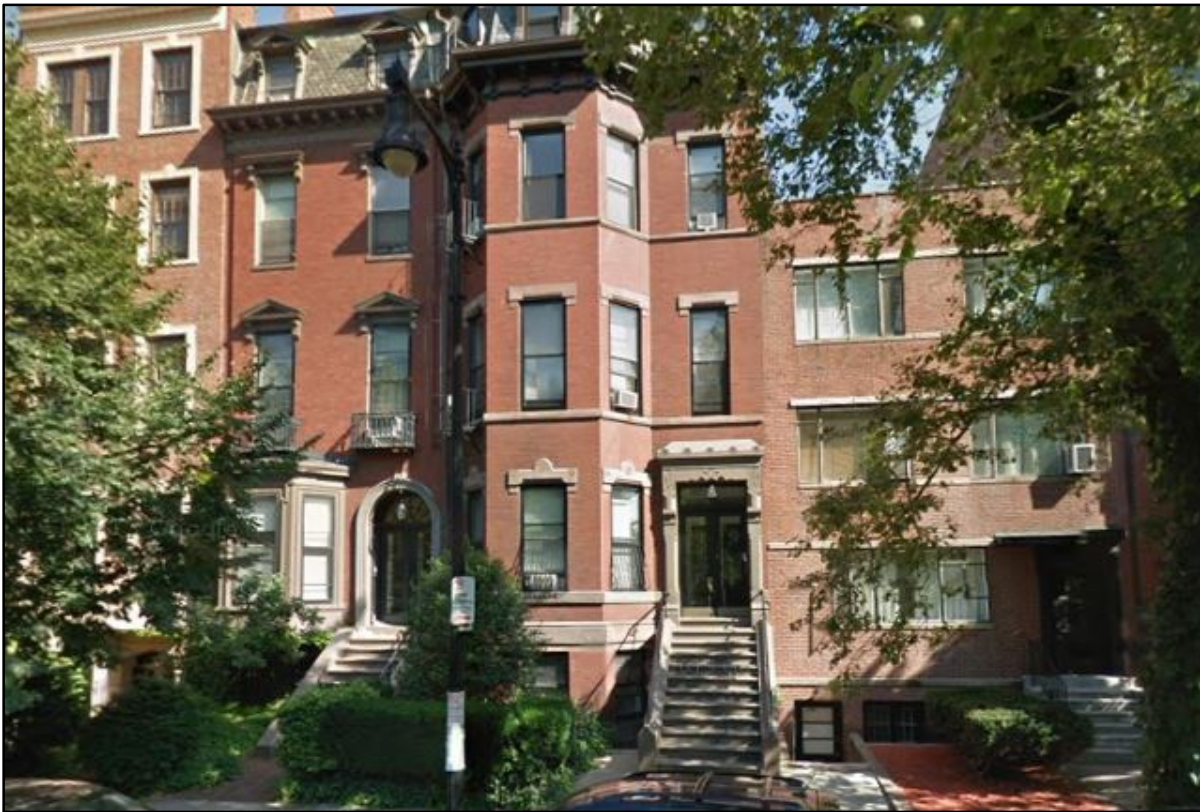
**Photo 1. The fire building is the one with the bay windows from the basement to the fourth floor. The entrance to the basement apartment is under the steps.**

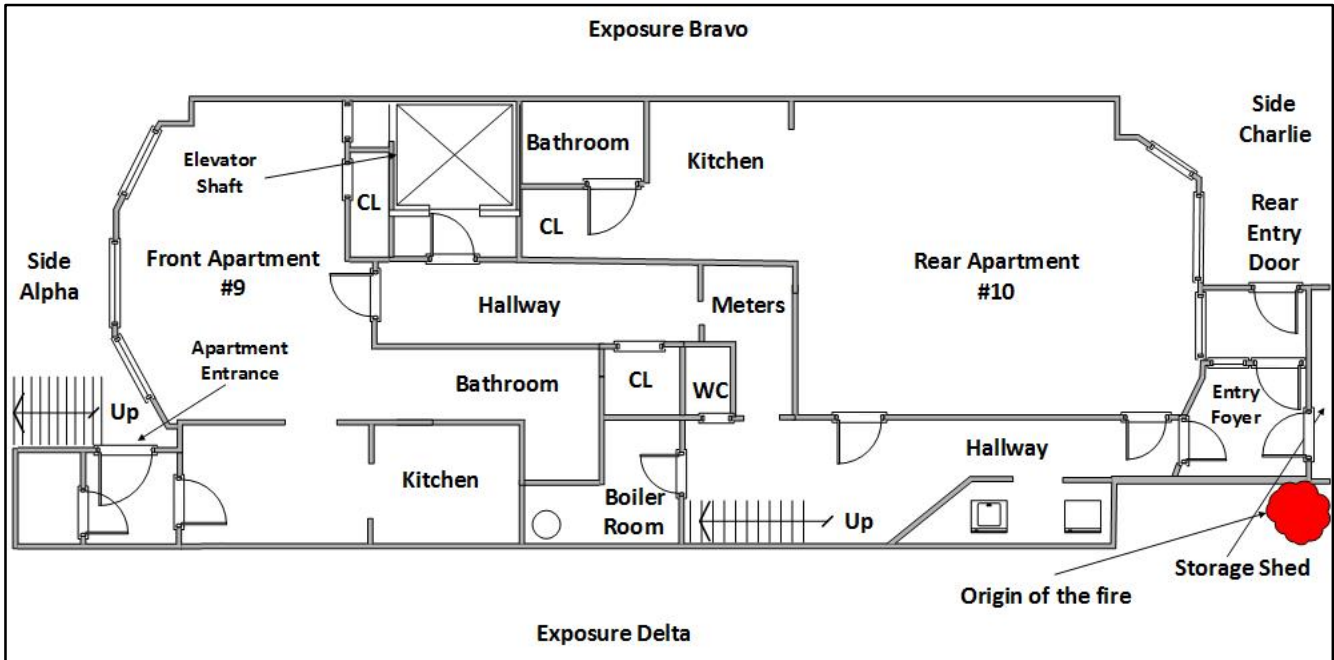
**Diagram 1. The diagram of the basement of the fire building. The front apartment is #9 and the rear apartment is #10. The shed was attached to the structure on Side Charlie, behind the rear entrance doors for the rear apartment.**

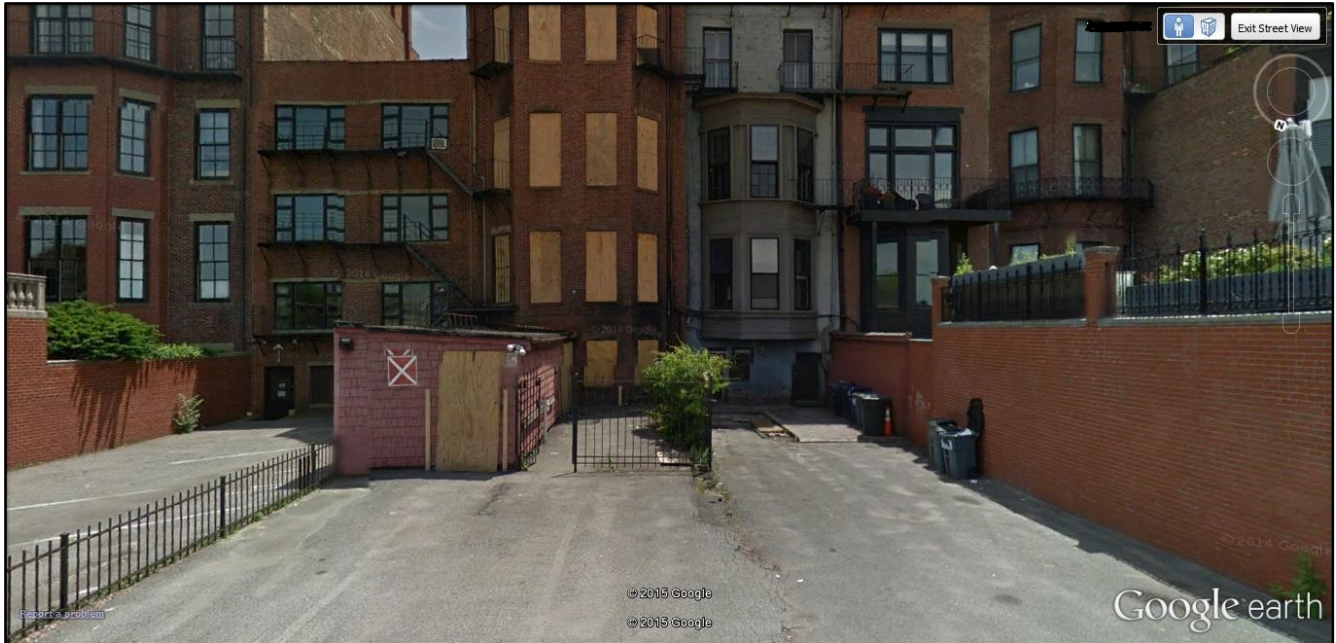
The fire started in a shed in the rear of the structure. The shed was attached to the building by the rear entrance. The shed served as the office, storage, and work facility for the property maintenance staff of the affected building (See **Photo 2**).

**Photo 2. A view of Side Charlie and the location of the maintenance shed.**  
(*Photo source: Google Earth.*)

The fire was ruled accidental by the county's district attorney. According to fire investigators, employees from a welding company accidentally started a fire in the maintenance shed in the rear of the fire building. The welding company employees were installing pre-fabricated wrought-iron railings in the rear of the Delta Exposure building. It was the opinion of the Fire Investigation Unit that the area of origin of this fire was the rear of the fire building, outside the shed wall facing the rear Delta Exposure. The cause of the fire was a heat source too close to combustible material, with combustion accelerated by high winds.

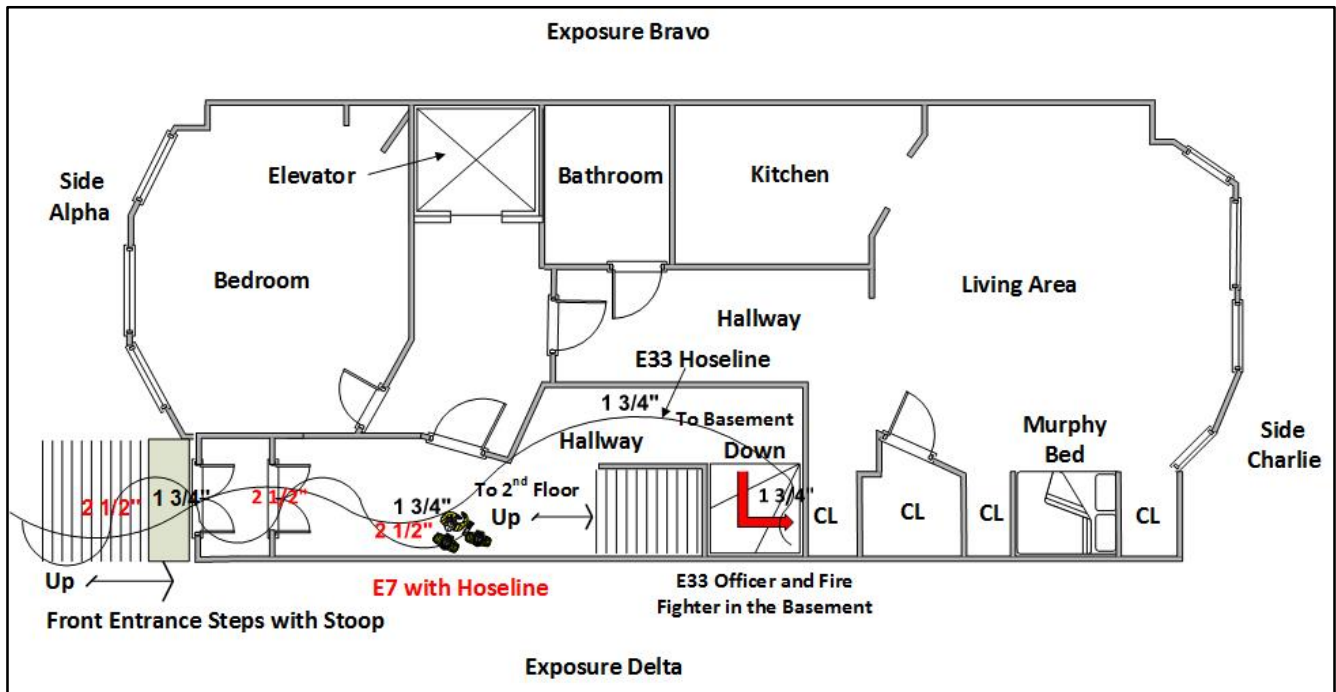
**Diagram 4. The initial hoseline operations entering through the front door of the first floor.**

**Engine 33 has taken a 1¾-inch hoseline into the basement. Engine 7 is pulling a 2½-inch hoseline into the front hallway of the first floor, moving toward the basement steps. The time is approximately 1449 hours.**

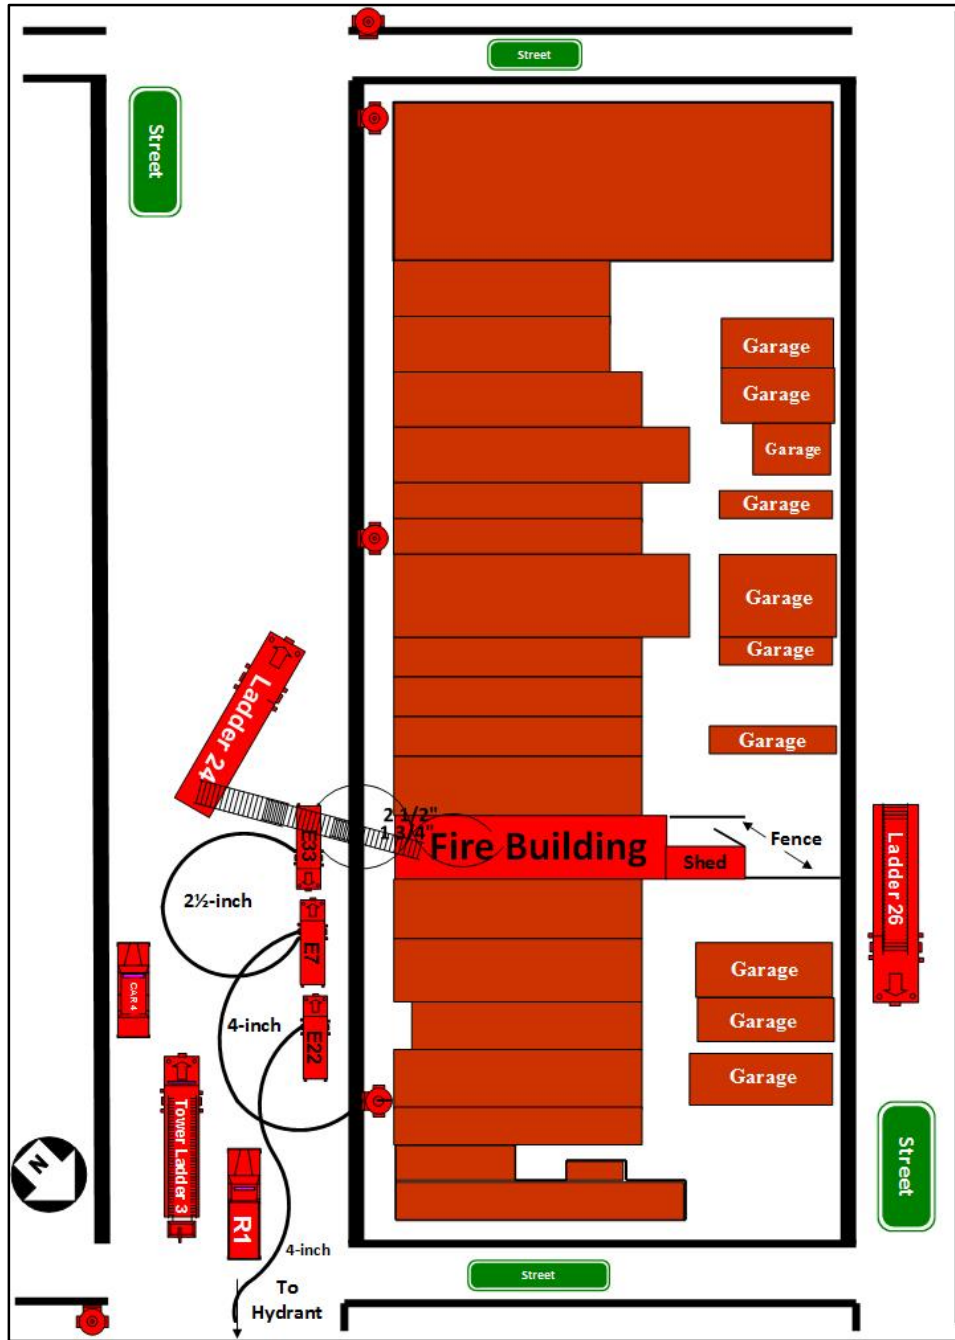
Diagram 5. The diagram of the initial engine company operations with Engine 33, Engine 7, and Engine 22 making entry into the fire building. The time is approximately 1449 hours.

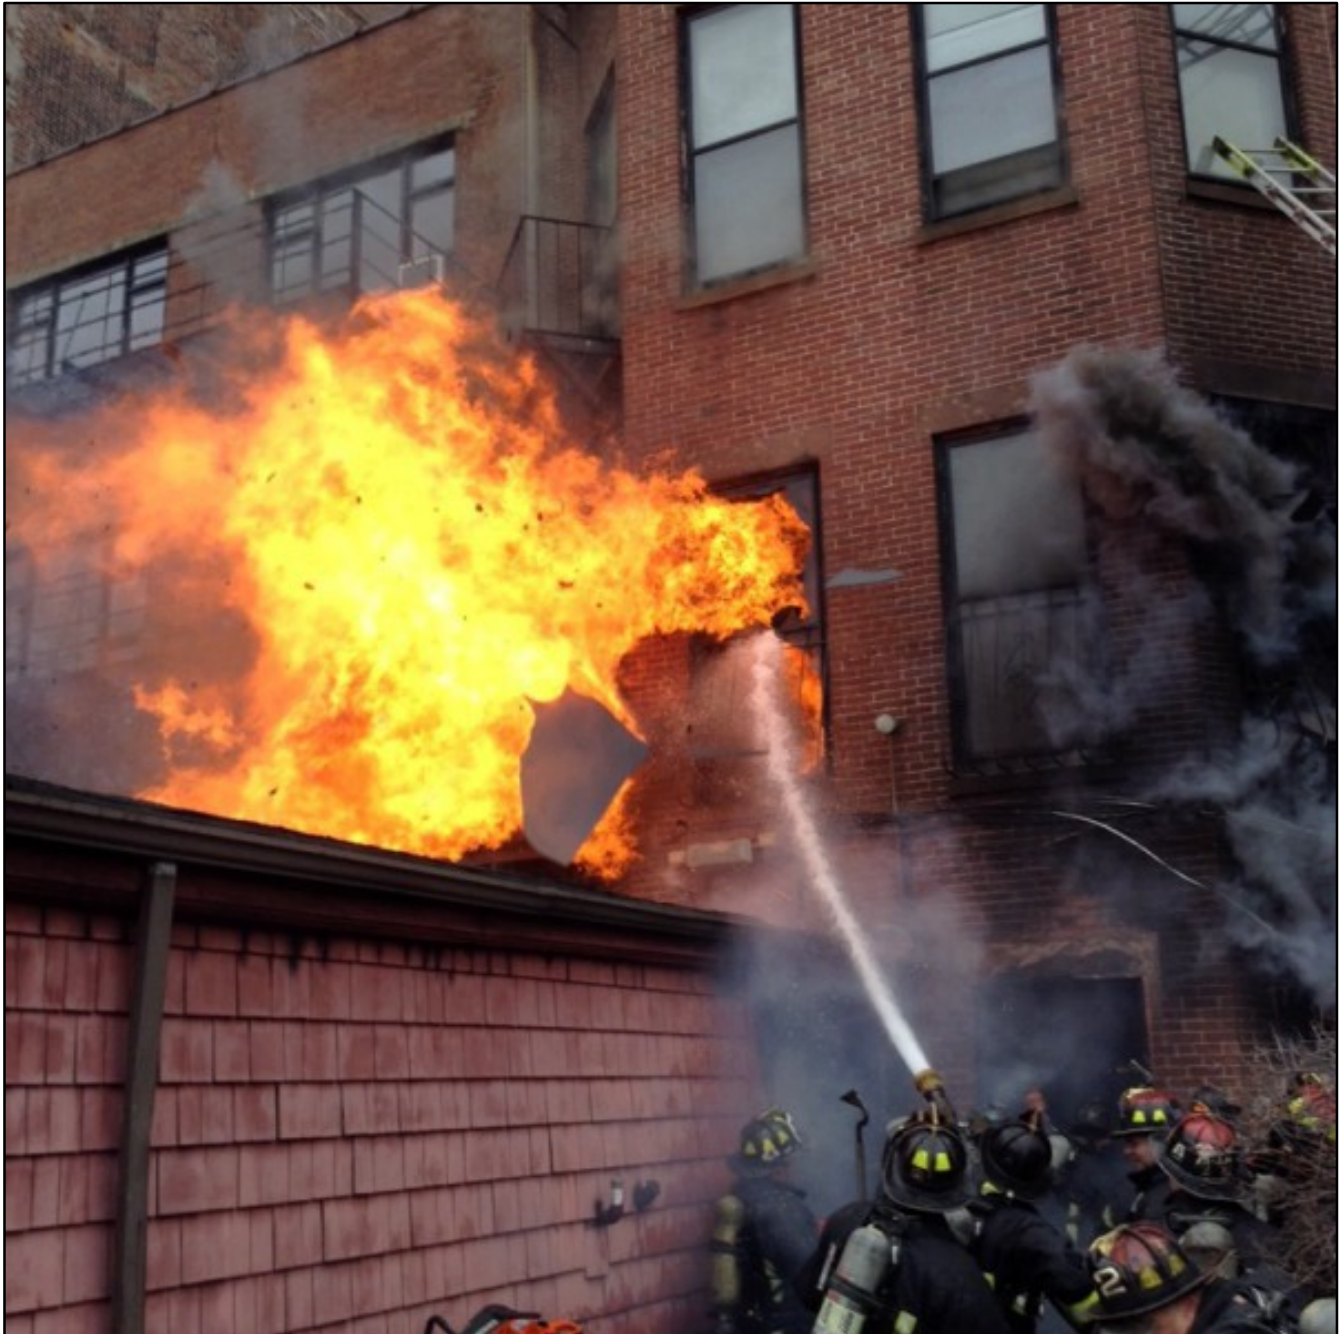
**Photo 3. A rapid progression of fire conditions occurred on the first floor at approximately 1511 hours. Crews were operating on Side Charlie (upwind side) and making entry into the rear basement apartment via the windows. This photo shows the force of the rapid progression of fire conditions.**

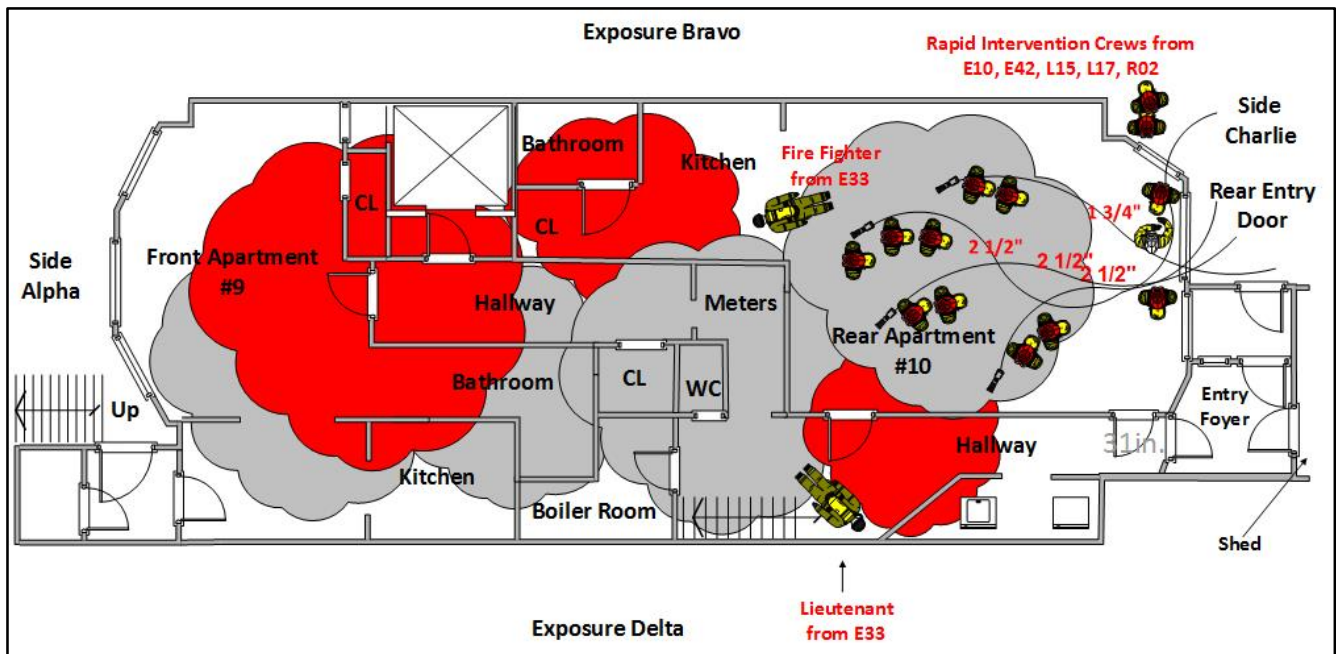
**Diagram 6. Crews from Engine 10, Engine 42, Ladder 15, Ladder 17, and Rescue 2 are operating the rear basement apartment searching for the lieutenant and fire fighter from Engine 33. Rescue 2 finds the fire fighter from Engine 33 and removed him from the building. The time is 1519 hours. The lieutenant was not located until 1848 hours.**

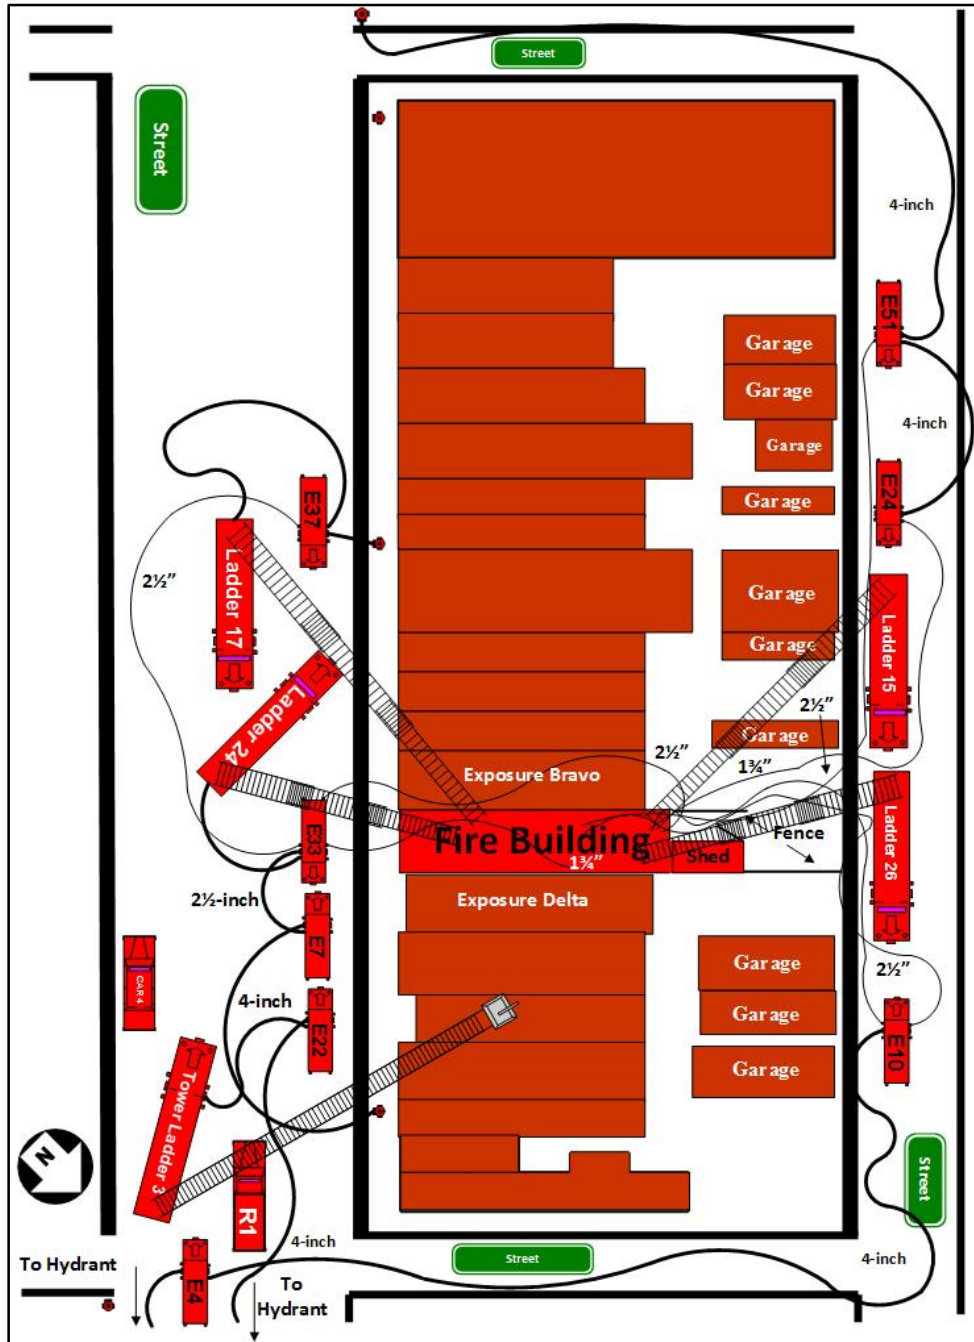
Diagram 7. Defensive operations. Ladder pipes, a tower ladder, and numerous deck guns plus hoselines are in operation. The time is approximately 1645 hours.

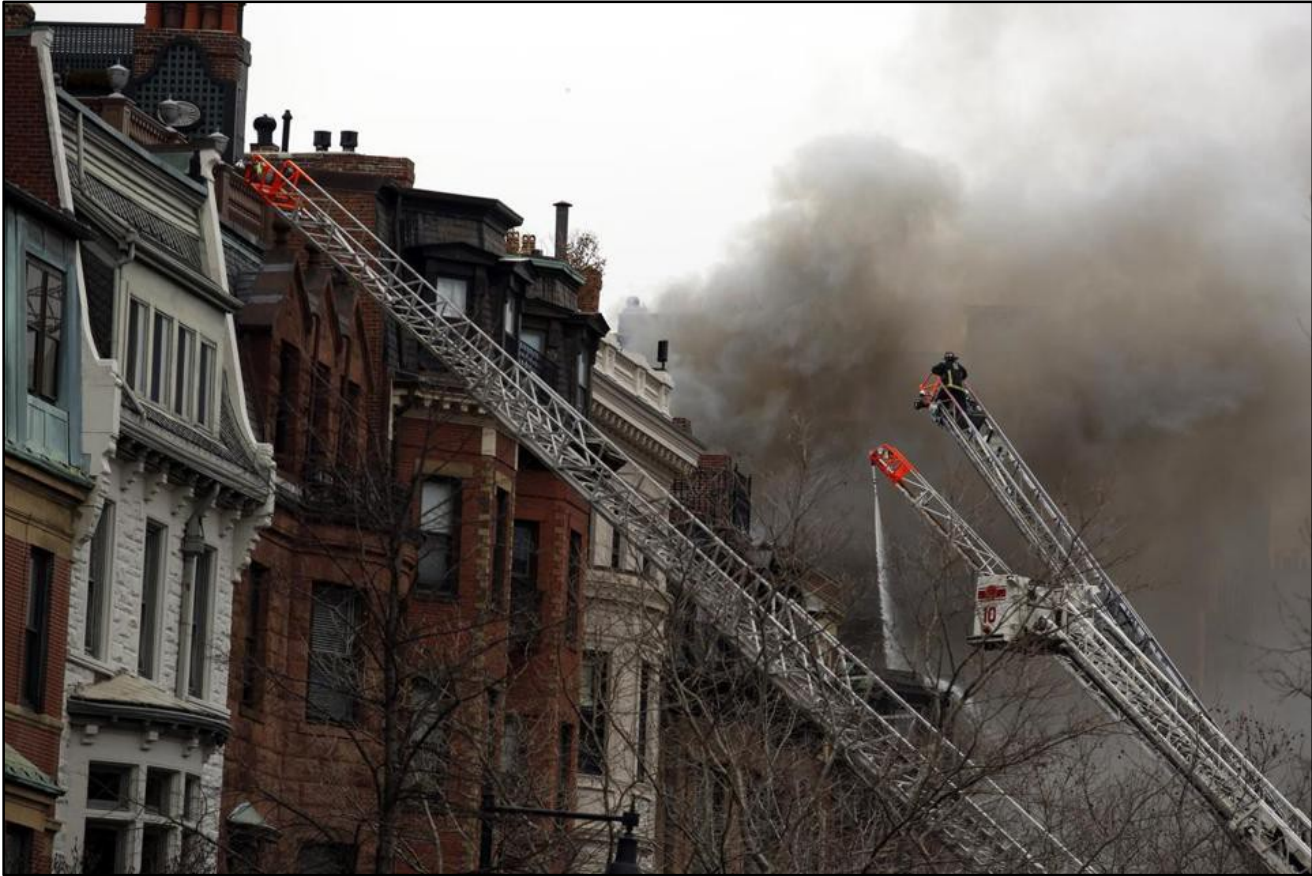
**Photo 4. Defensive operations on Side Alpha of the fire building. Three ladder pipes, a tower ladder, numerous deck guns, and hoselines are in operation. The time is approximately 1615 hours.**  
*(Photo courtesy of the fire department.)*
