BOX 4-281

Board of Inquiry Report on fatal fire of August 29th, 2007

Date report issued: February 15, 2008

Report on: Box 4-281 Centre Street and Manthorne Road
Fatal Fire on August 29, 2007
Incident number # 47497
1727 Centre Street
West Roxbury
District 10
Division 2

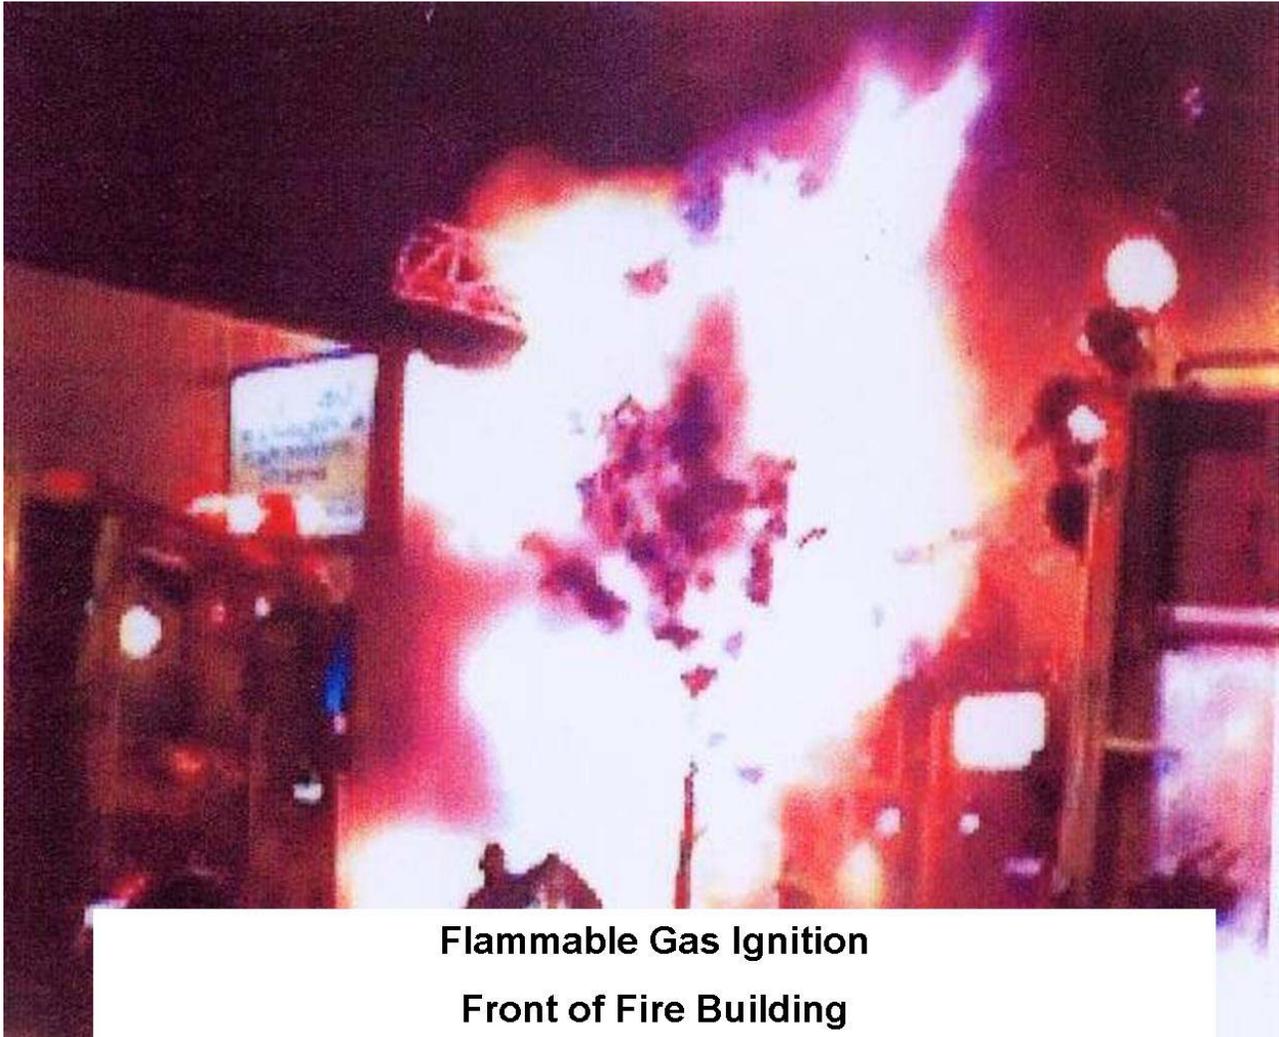
During the course of performing an initial aggressive interior firefighting operation, Firefighters Cahill and Payne were subjected to a flammable gas ignition and ensuing rapid fire progression resulting in a sudden intensification of fire and smoke conditions within the fire building.

**Flammable Gas Ignition
Front of Fire Building**

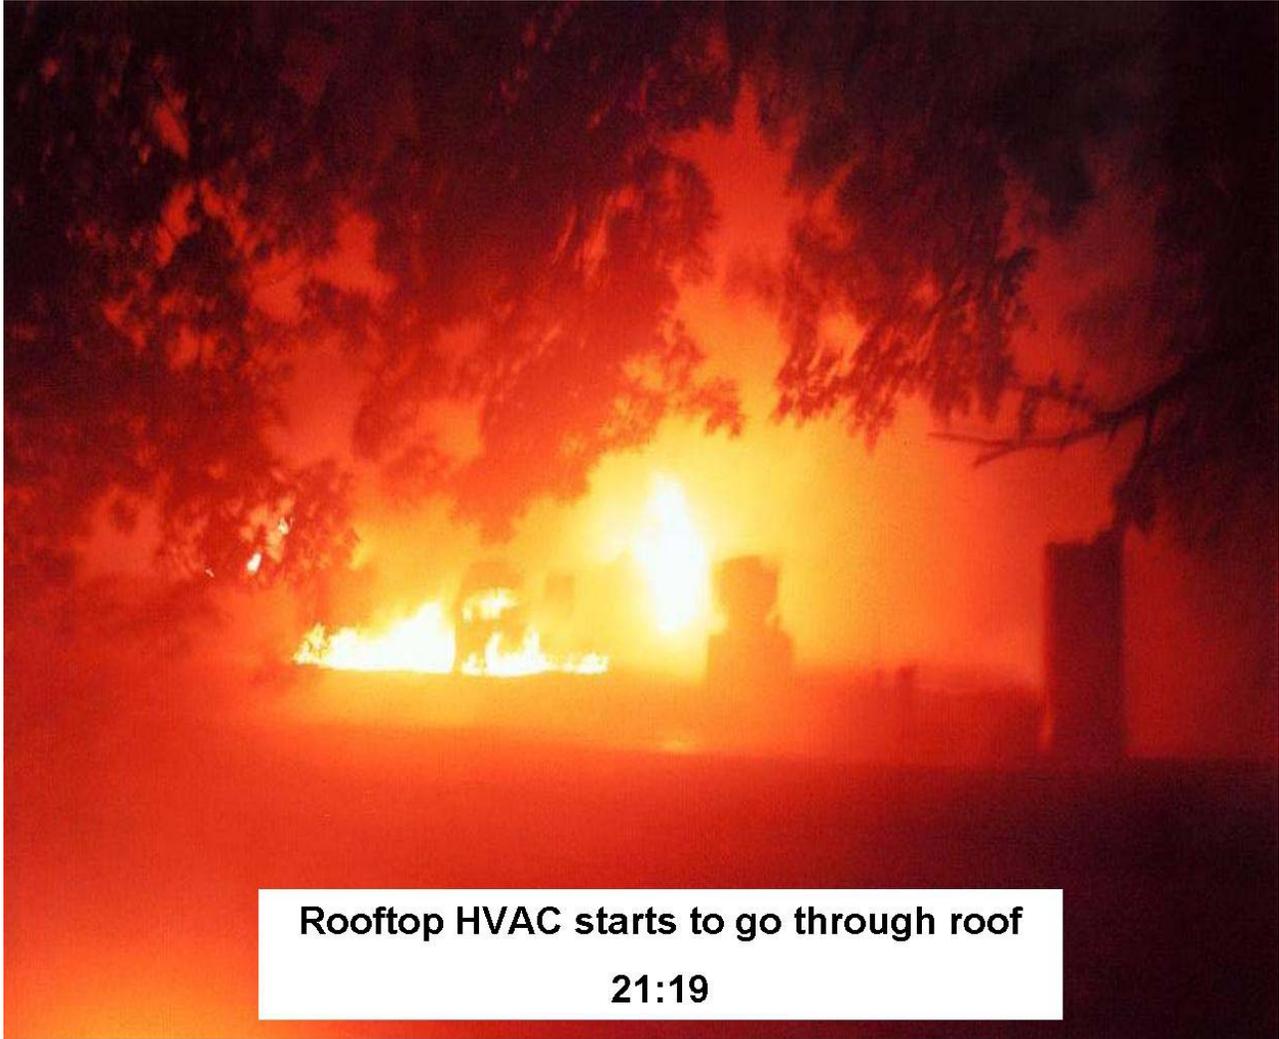
21:19

21:18:50
Ladder 10's Roof Man sees the air conditioning unit move and reports it to Fire Alarm

Ladder 10 reports an air conditioner unit is "through the roof. We could use a line up here"

Rooftop HVAC starts to go through roof

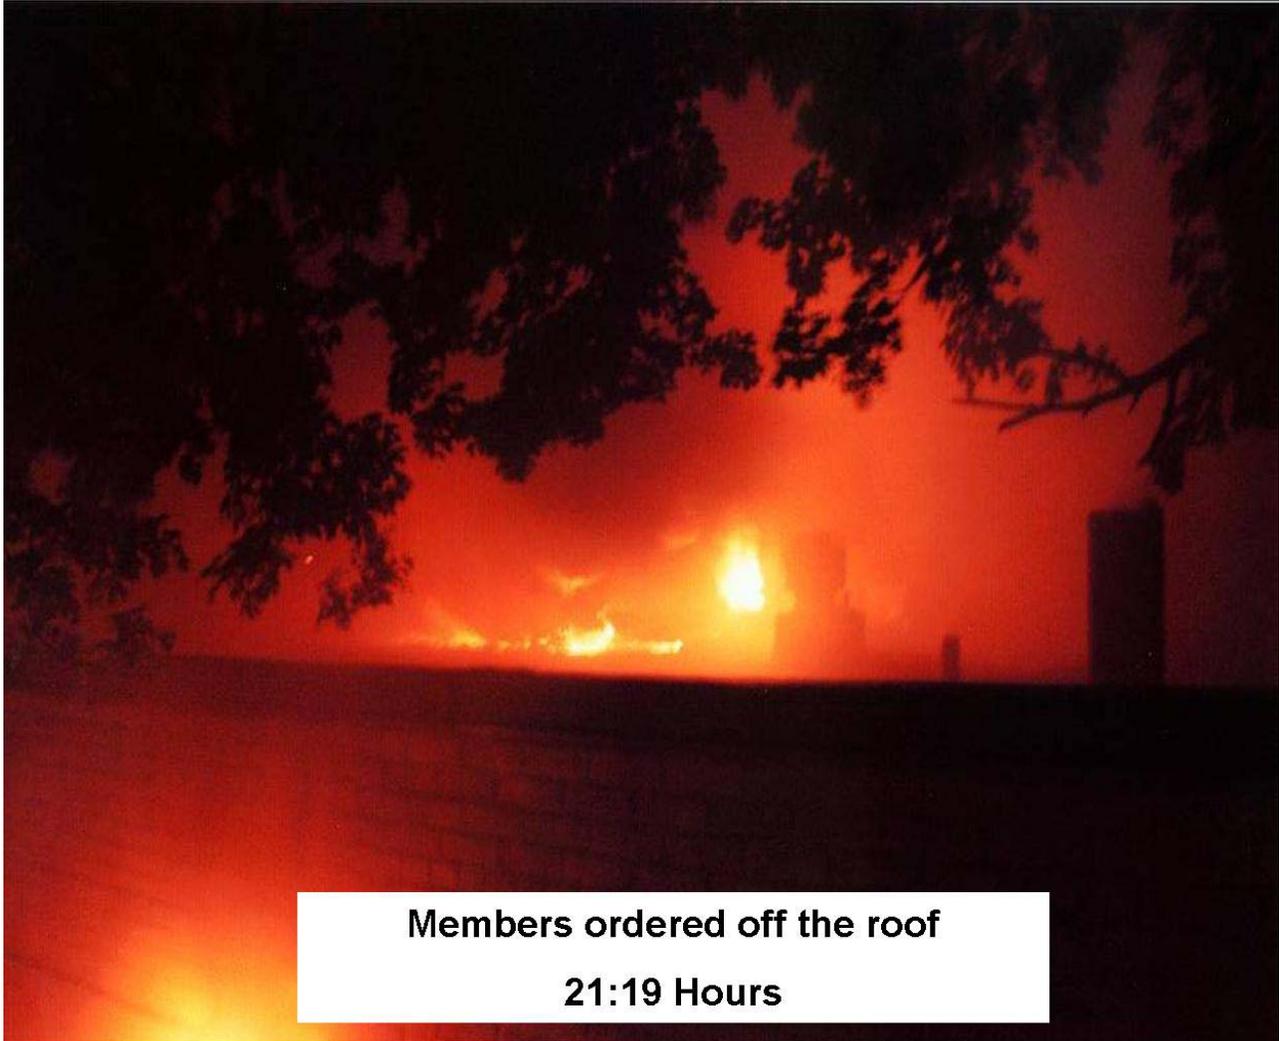
21:19 Hours

Members ordered off the roof

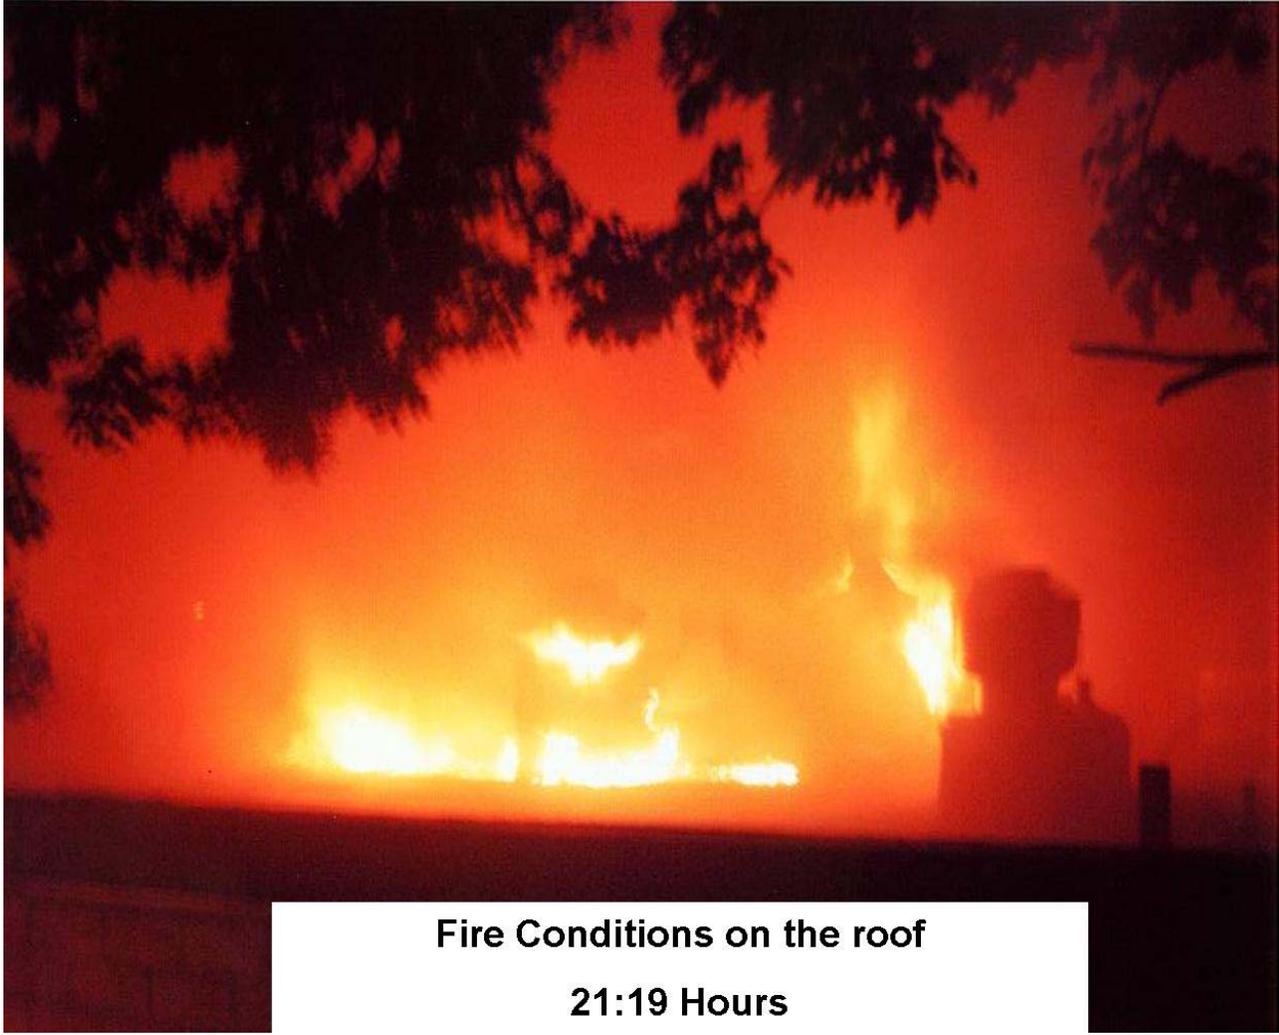
Fire Conditions on the roof
21:19 Hours

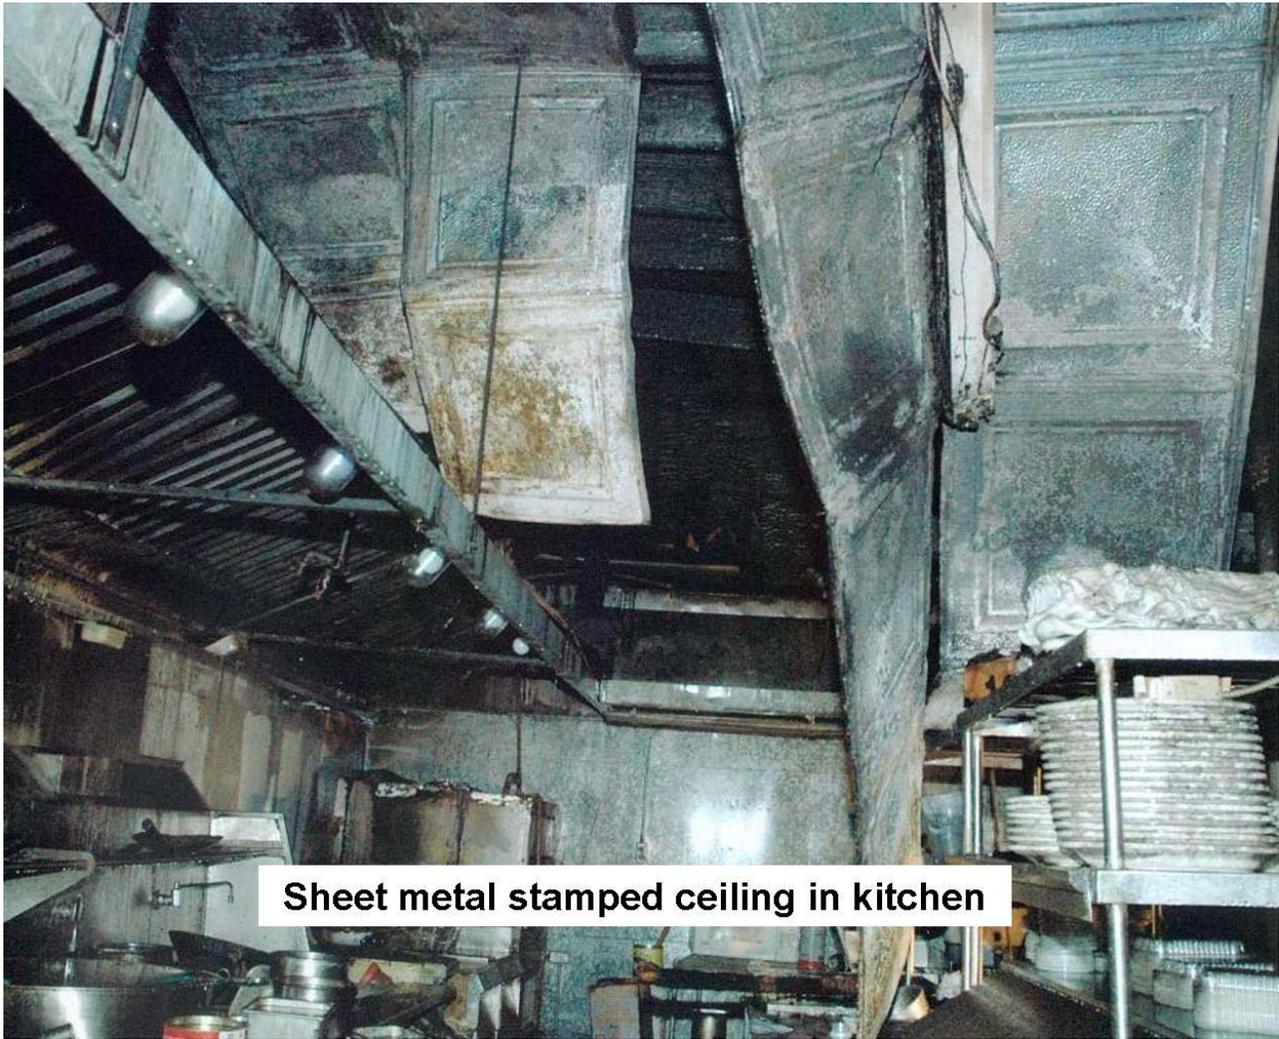
Sheet metal stamped ceiling in kitchen

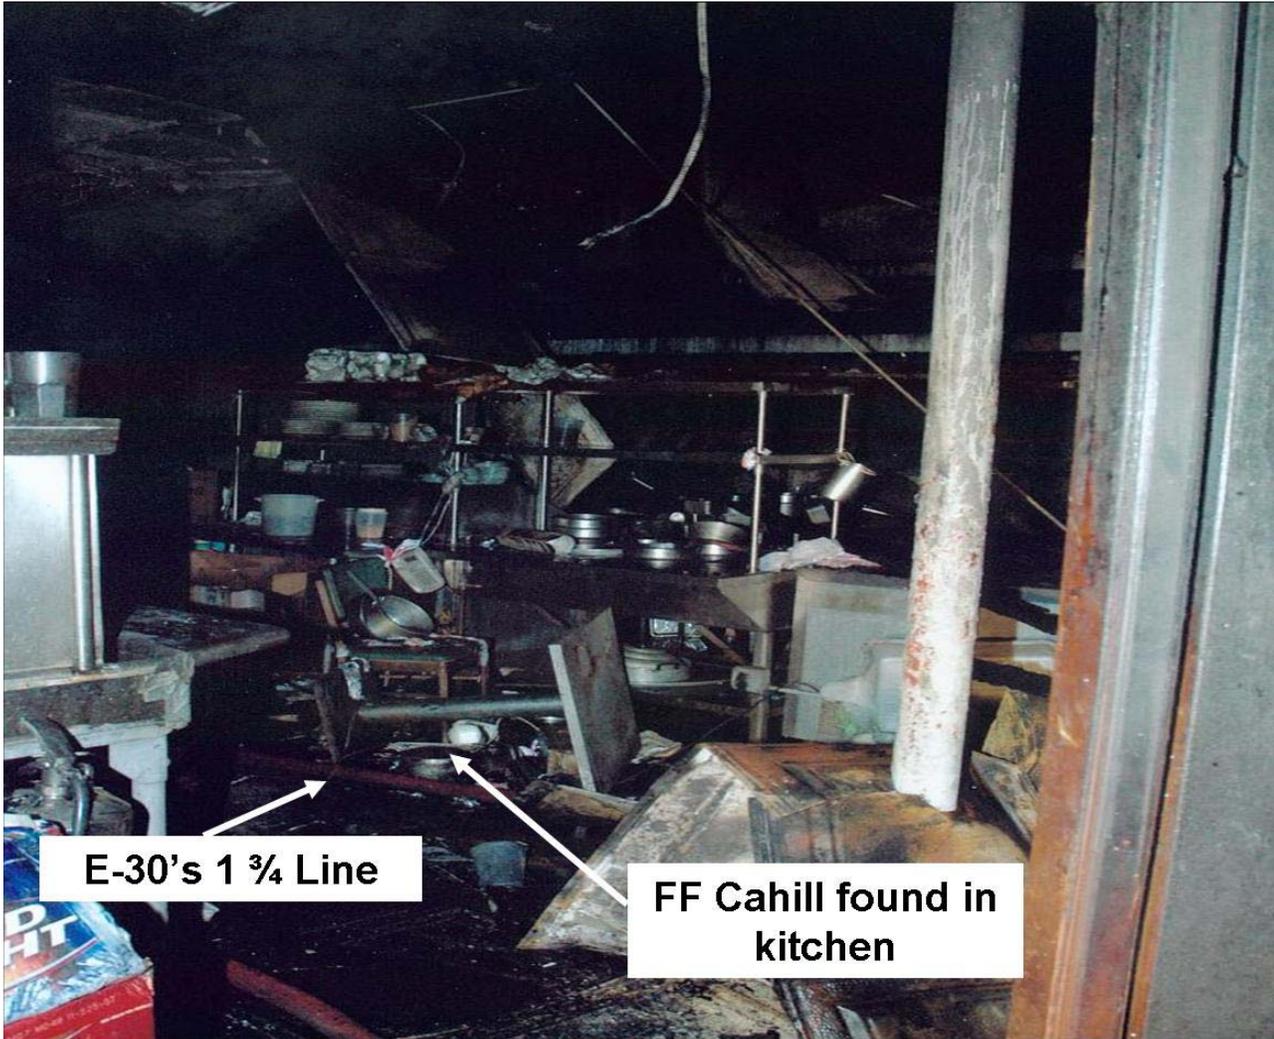
Rescue Company 2's Officer and two members of Rescue Company 2 searching in the rear of the fire building located Firefighter Cahill. He was found face down covered with debris in the kitchen with Engine Company 30's line. Firefighter Cahill's face piece was off and his PASS device was operating when he was located. Difficulty was encountered in removing Firefighter Cahill due to his entanglement in debris. After several attempts he was freed from the debris and removed to the rear alley where H-1 administered CPR. Firefighter Cahill was quickly moved to the front of the fire building and was treated and transported by Boston EMS to the Faulkner hospital.

**FF Cahill found in
kitchen**

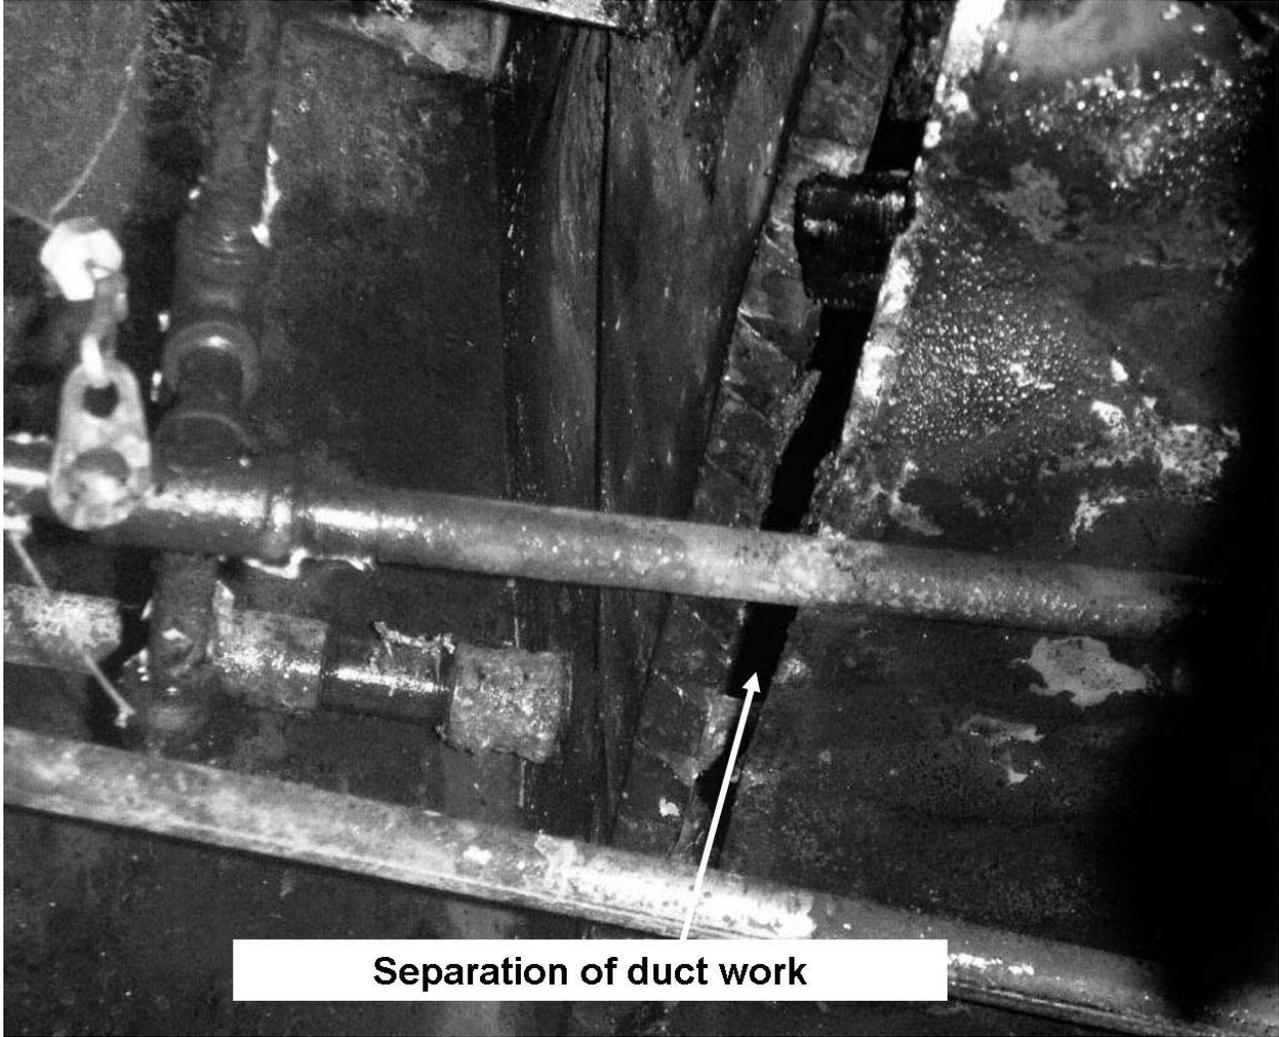
- 13] The duct at the ceiling level was degraded with an opening approximately 1 inch wide by 12 inches long.

As a result of the substandard materials being used over some period of time the duct above the hood degraded and a section of the duct became open approximately 1" x 12". This area showed signs of rust. Flame and products of combustion, including heat, carbon monoxide and other fire gases escaped from the duct. Combustible building materials over some period of time became coated with grease. The fire in the duct work above the hood escaped from containment and ignited combustible wall materials and extended vertically to the ceiling joists and ultimately the roof joists. The smoke and fire gases expanded and traveled horizontally filling both the top and bottom ceiling voids in the dining room as well as the 24" ceiling void in the kitchen.

Separation of duct work

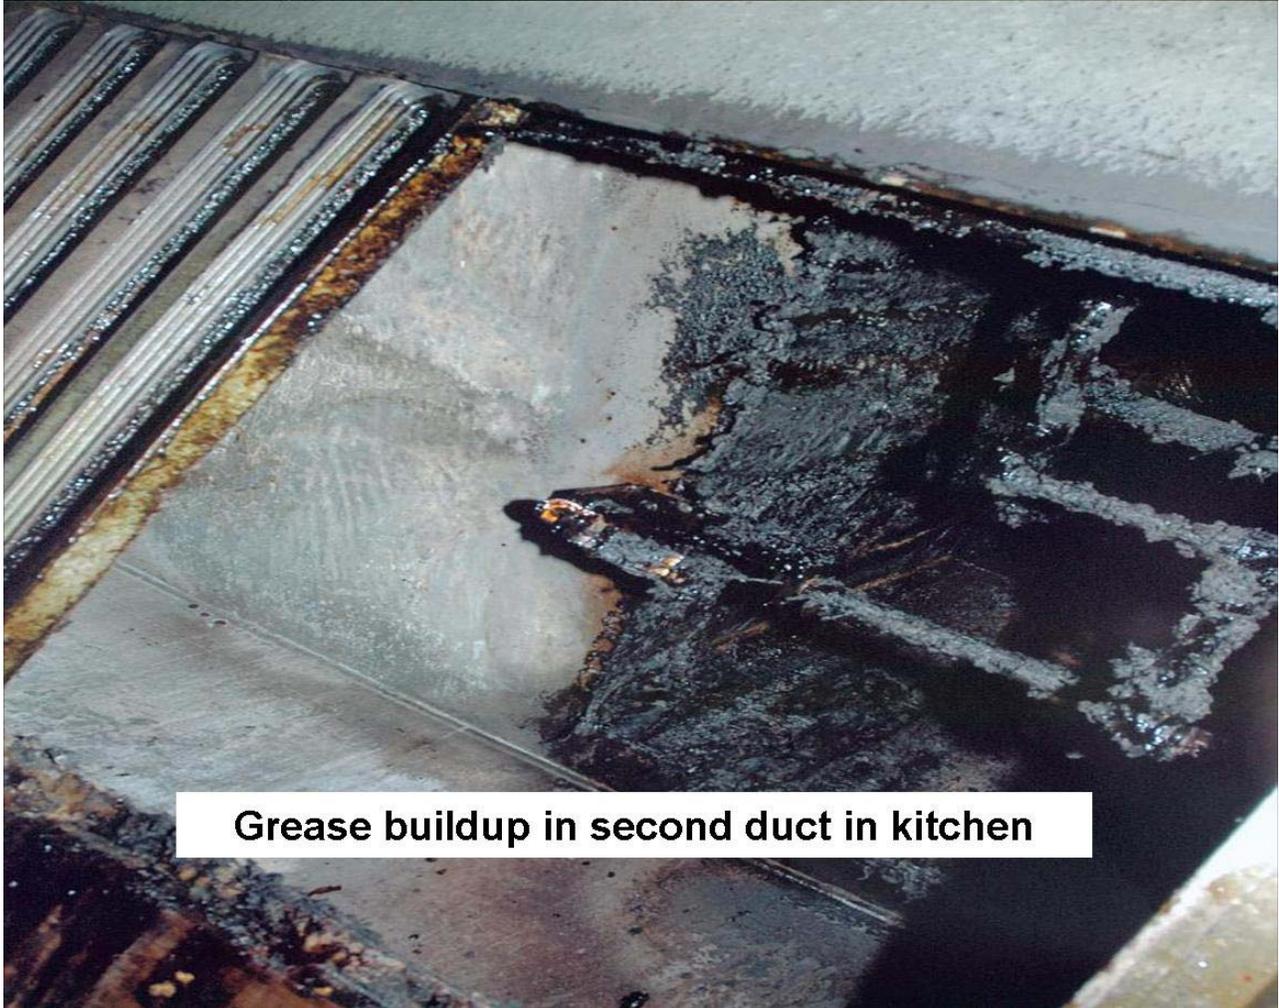
- 11] The hood and duct system was totally contaminated with excessive grease and no maintenance label was found.
- 12] Fryers were adjacent to a broiler/oven and must have a clearance of 16".

Grease buildup in second duct in kitchen

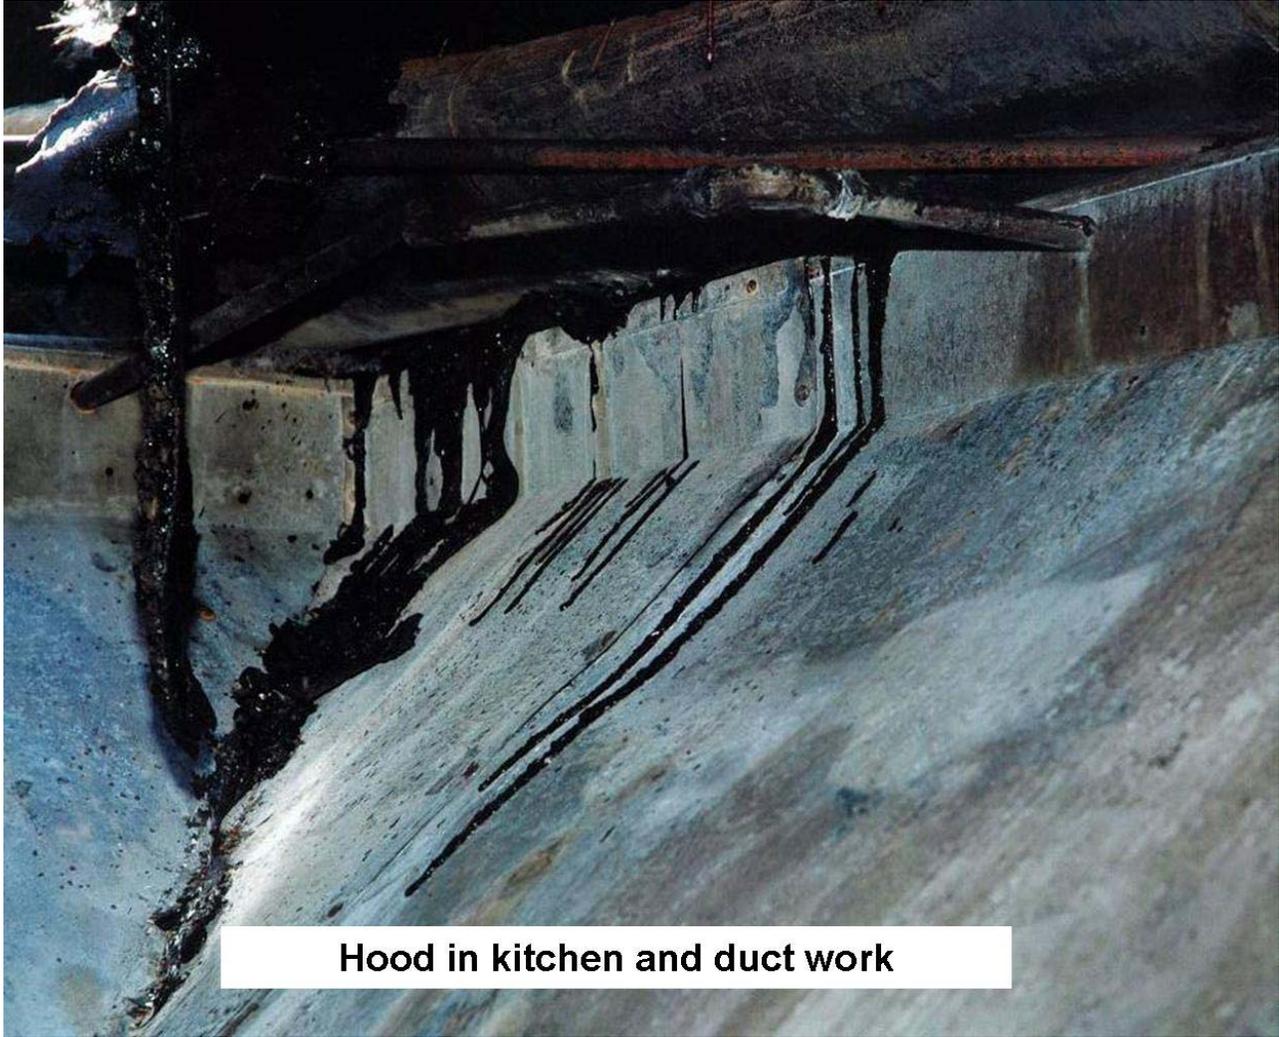
Hood in kitchen and duct work

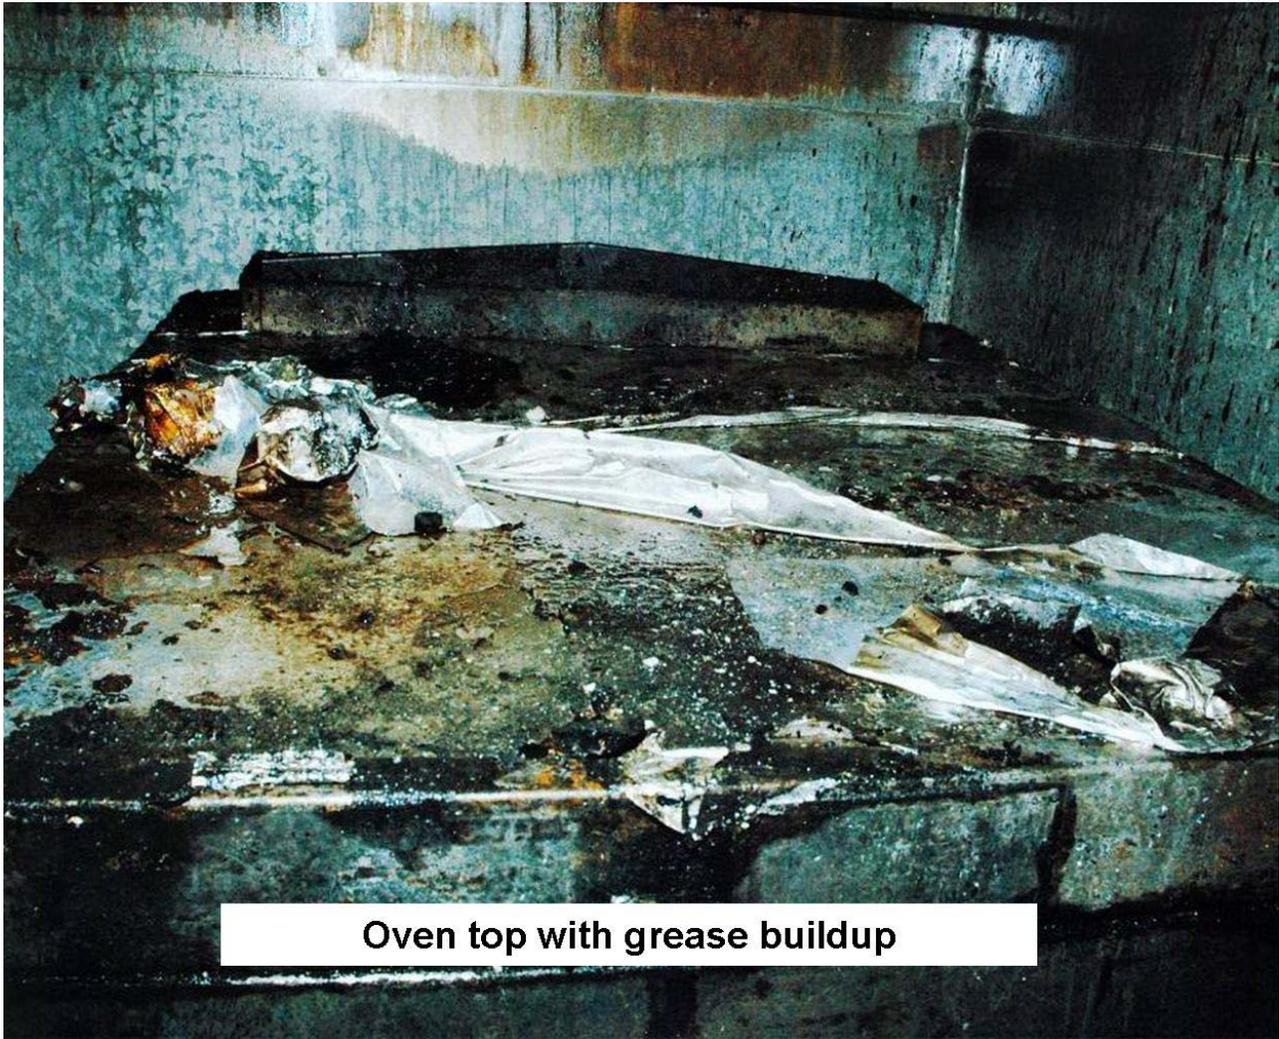
Oven top with grease buildup

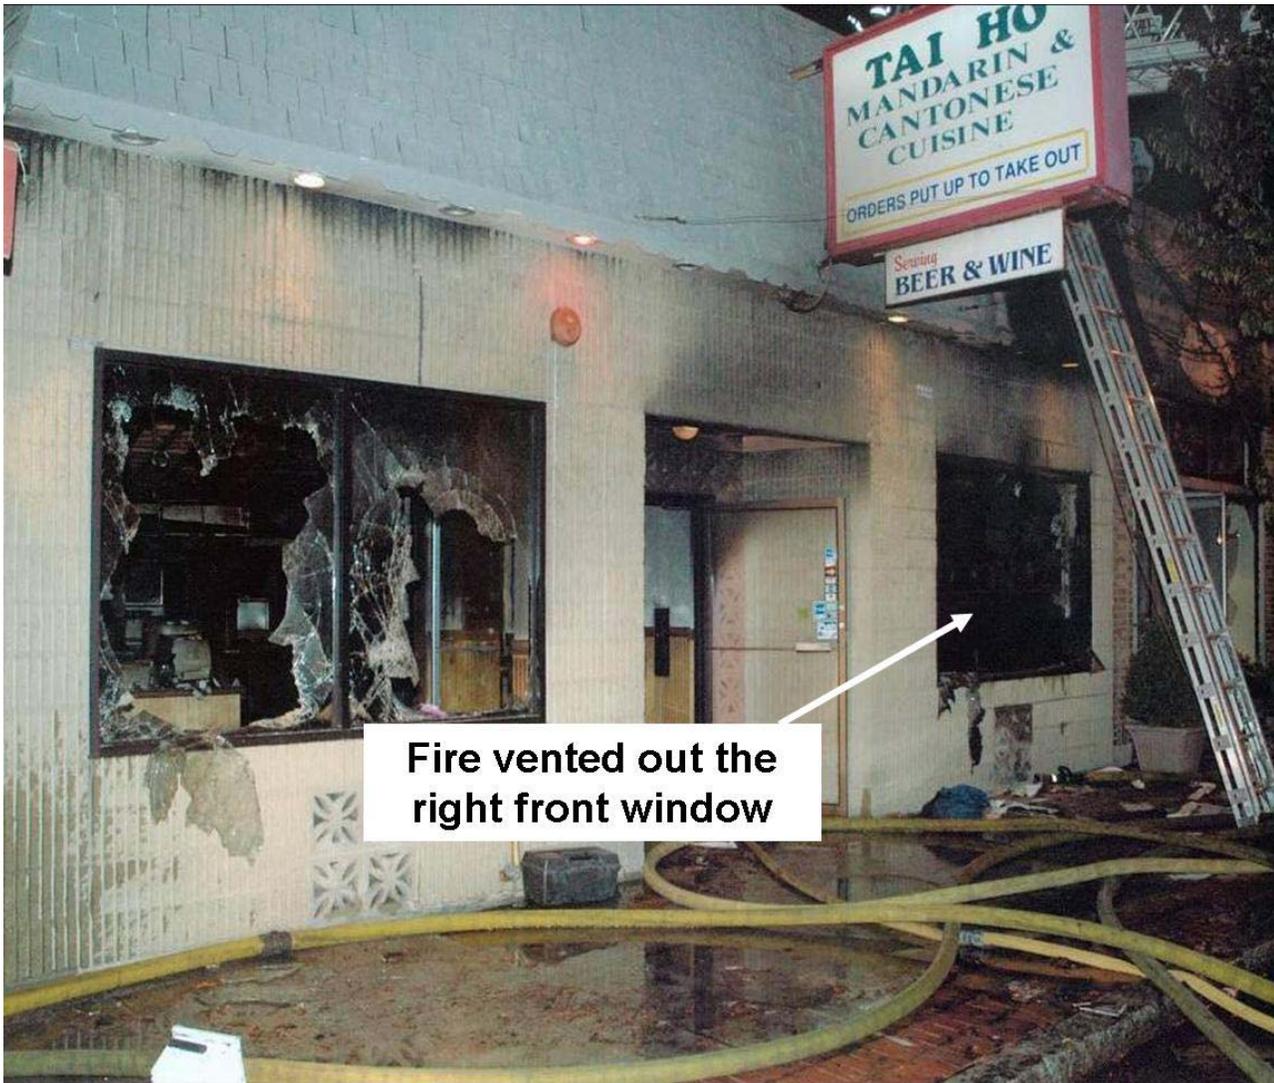
Fire vented out the right front window

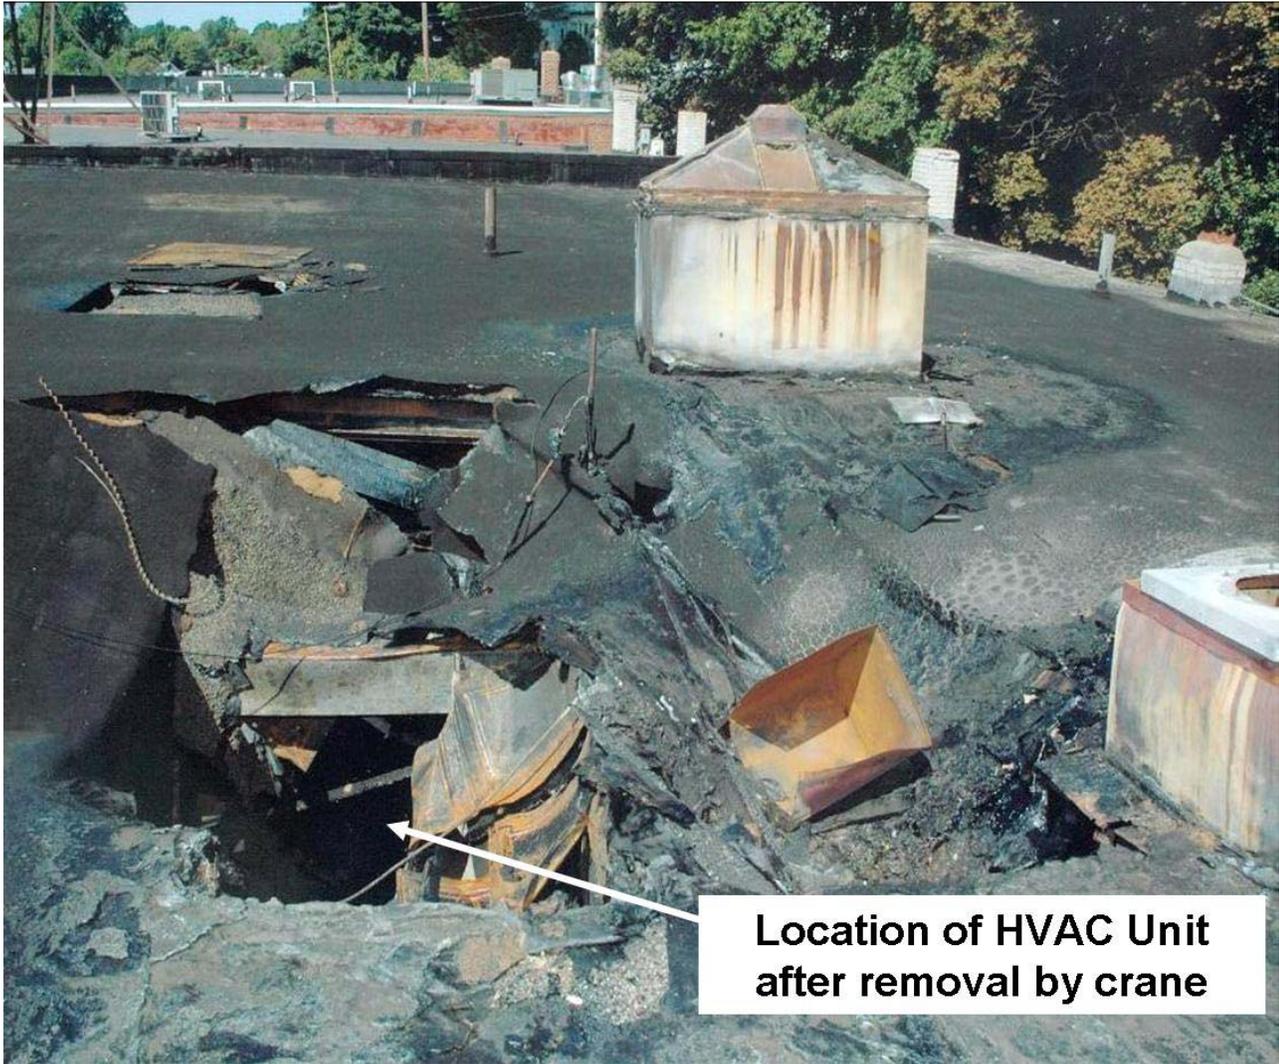
C-3 requested a crane be dispatched to the incident in order to mitigate a hazardous condition involving a rooftop HVAC unit in danger of falling into the fire building.

**Location of HVAC Unit
after removal by crane**
