# The Gibson House (Interior)

Boston Landmarks Commission Study Report

Petition #149 137 Beacon Street, Boston

The Gibson House Interior

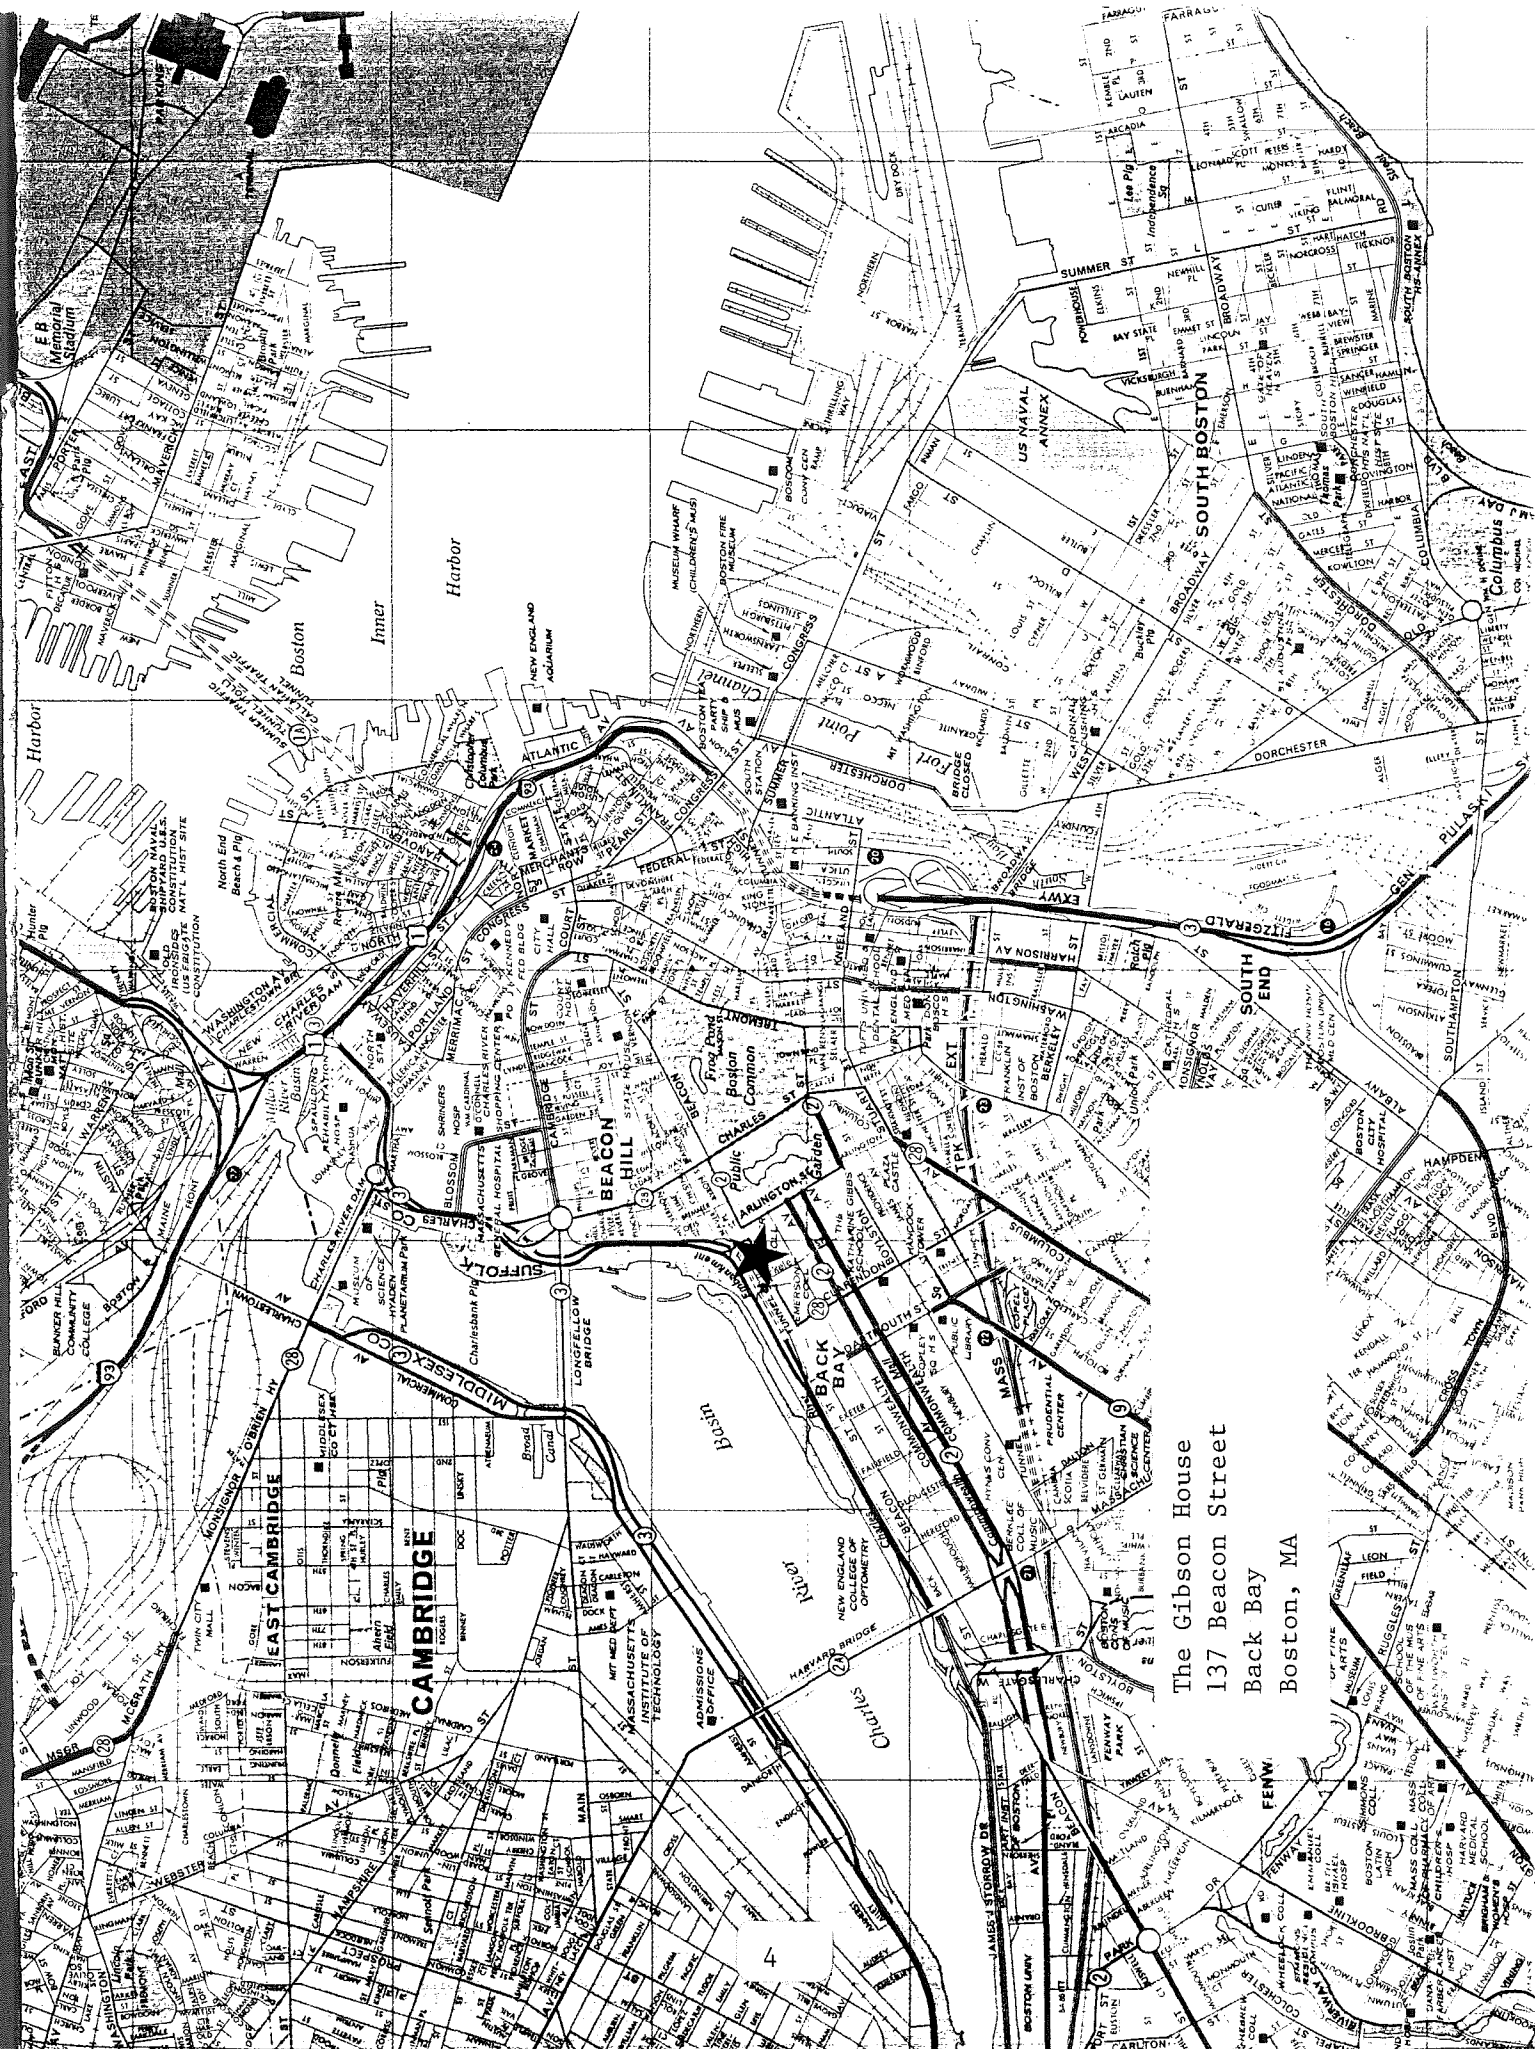
1.3 Map showing location:

The Gibson House  
137 Beacon Street  
Back Bay  
Boston, MA

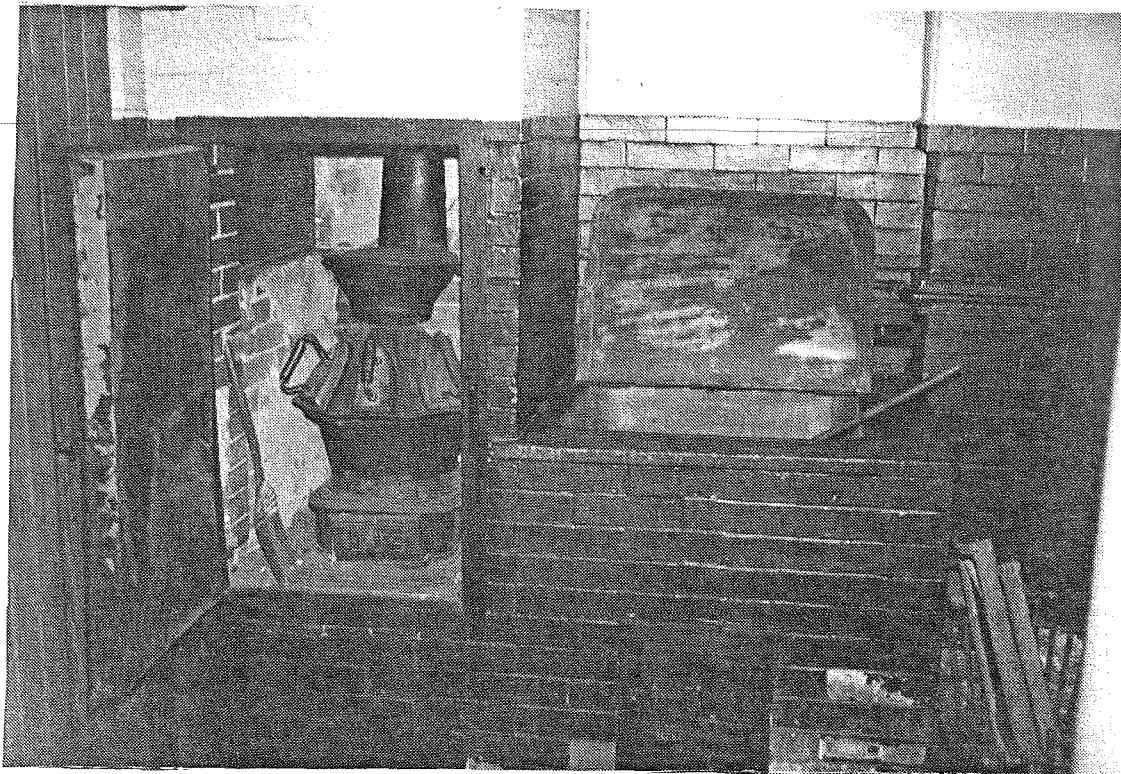
Original Boiler Tub & Iron Stove in Laundry Room

In the kitchen, the soapstone sink was moved from the south to the west wall in the early 1960s. The original coal furnace was replaced by an oil furnace and a modern gas hot water heater. The laundry room survives intact. Modern appliances, partially hidden by a dividing wall, were added for the resident staff. A window was cut into the side wall of the drying room in the 1960s, for viewing inside during museum tours.

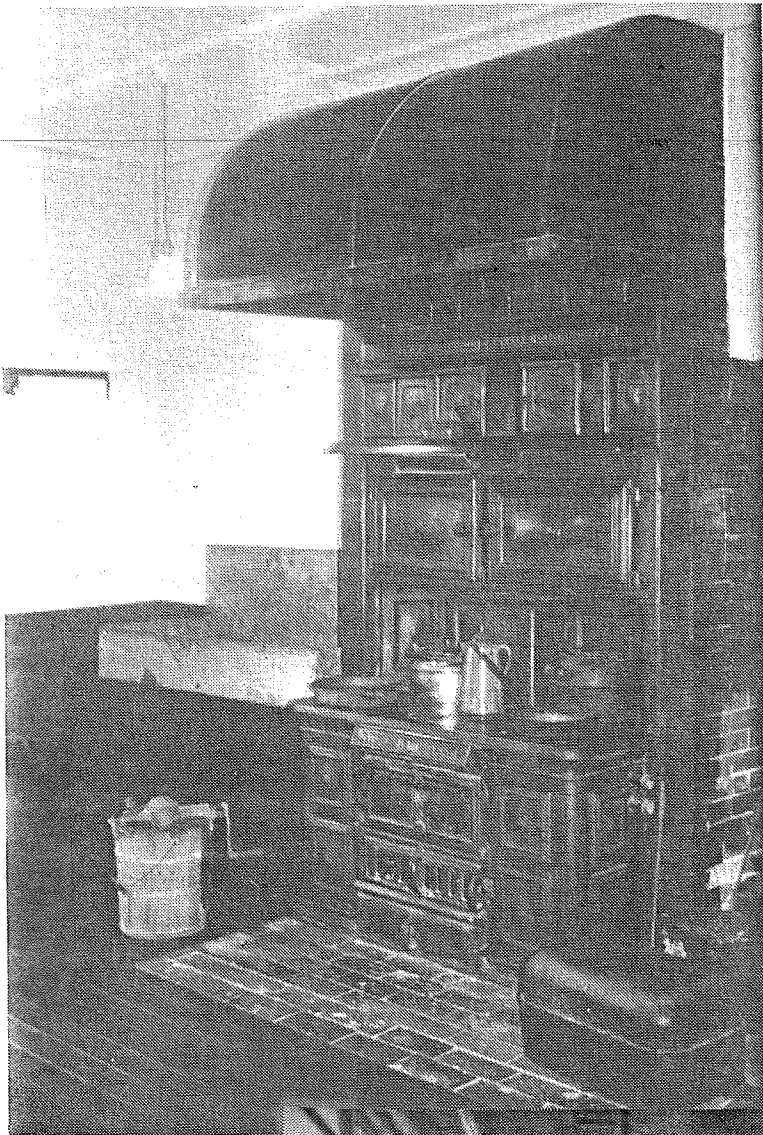
Smith & Anthony Stove, 1884  
(Left)

Finally, the basement kitchen and pantry furnishing or fixtures, include a built-in cast iron Smith & Anthony stove, a replacement dating from 1884, built in cupboards and drawers, and a soap-stone sink. The ice box was a later addition, and the majority of the contents of the kitchen have been added during the museum period, including the copper hot water heater. In addition, built-in wardrobes and cupboards can be found throughout the third, fourth and fifth floors.

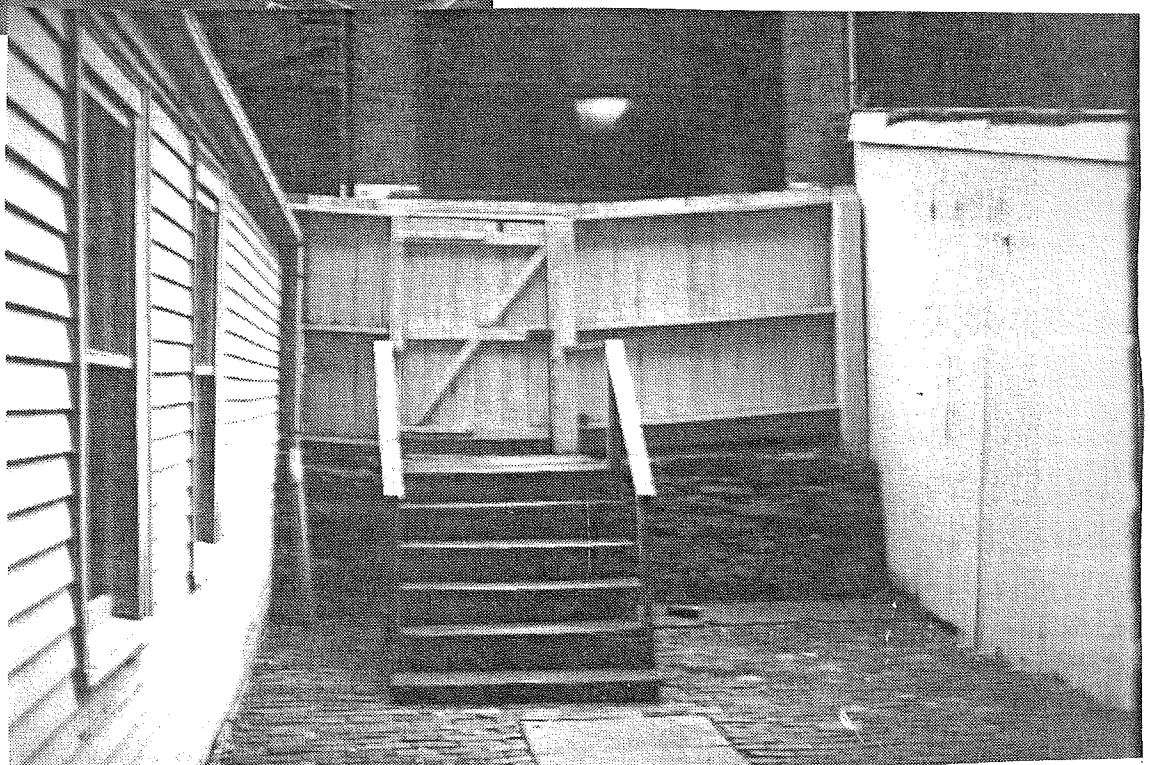
Rear Courtyard, Adjacent to Kitchen  
BASEMENT (GROUND FLOOR)

A long, rectangular shed adjoins the rear of the house at the eastern edge of the property. The shed contains a coal bin serviced from the alley, a cold pantry and a closet. The cold pantry has a zinc floor and stained matchboard walls.

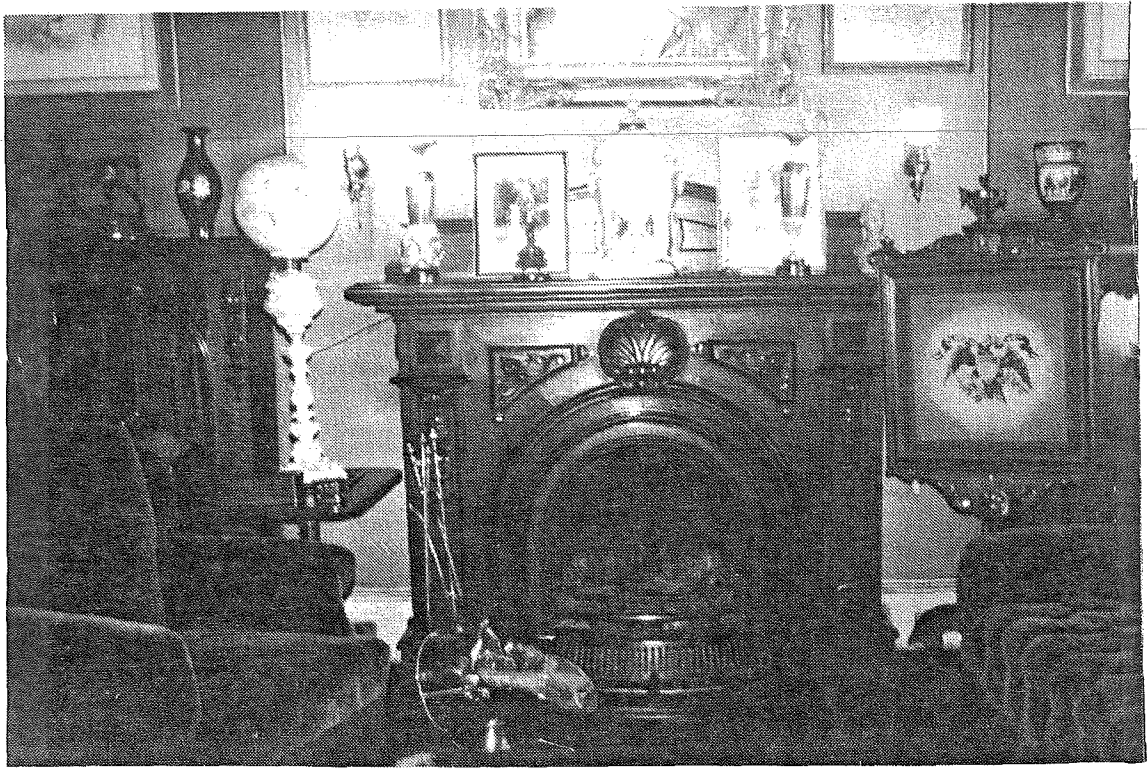
View of Fireplace in the Library

Arched black walnut doors divide the hallway and the rooms. The library, at the front half of the house, is illuminated by an oriel window in the north elevation. The west wall is dominated by a black walnut mantelpiece which surrounds a coal-burning fireplace. The library wallpaper, like the paper used in the dining room, is a slightly tarnished, gold burlap pattern.
