BOARD OF INQUIRY REPORT

298 BEACON STREET
BOSTON, MASSACHUSETTS

INCIDENT # 14-16454

Report on: The Line-of-Duty Fatal Fire on March 26, 2014
298 Beacon Street Boston, Massachusetts
District 4, Division 1
Incident # 16454 Box 9-1579

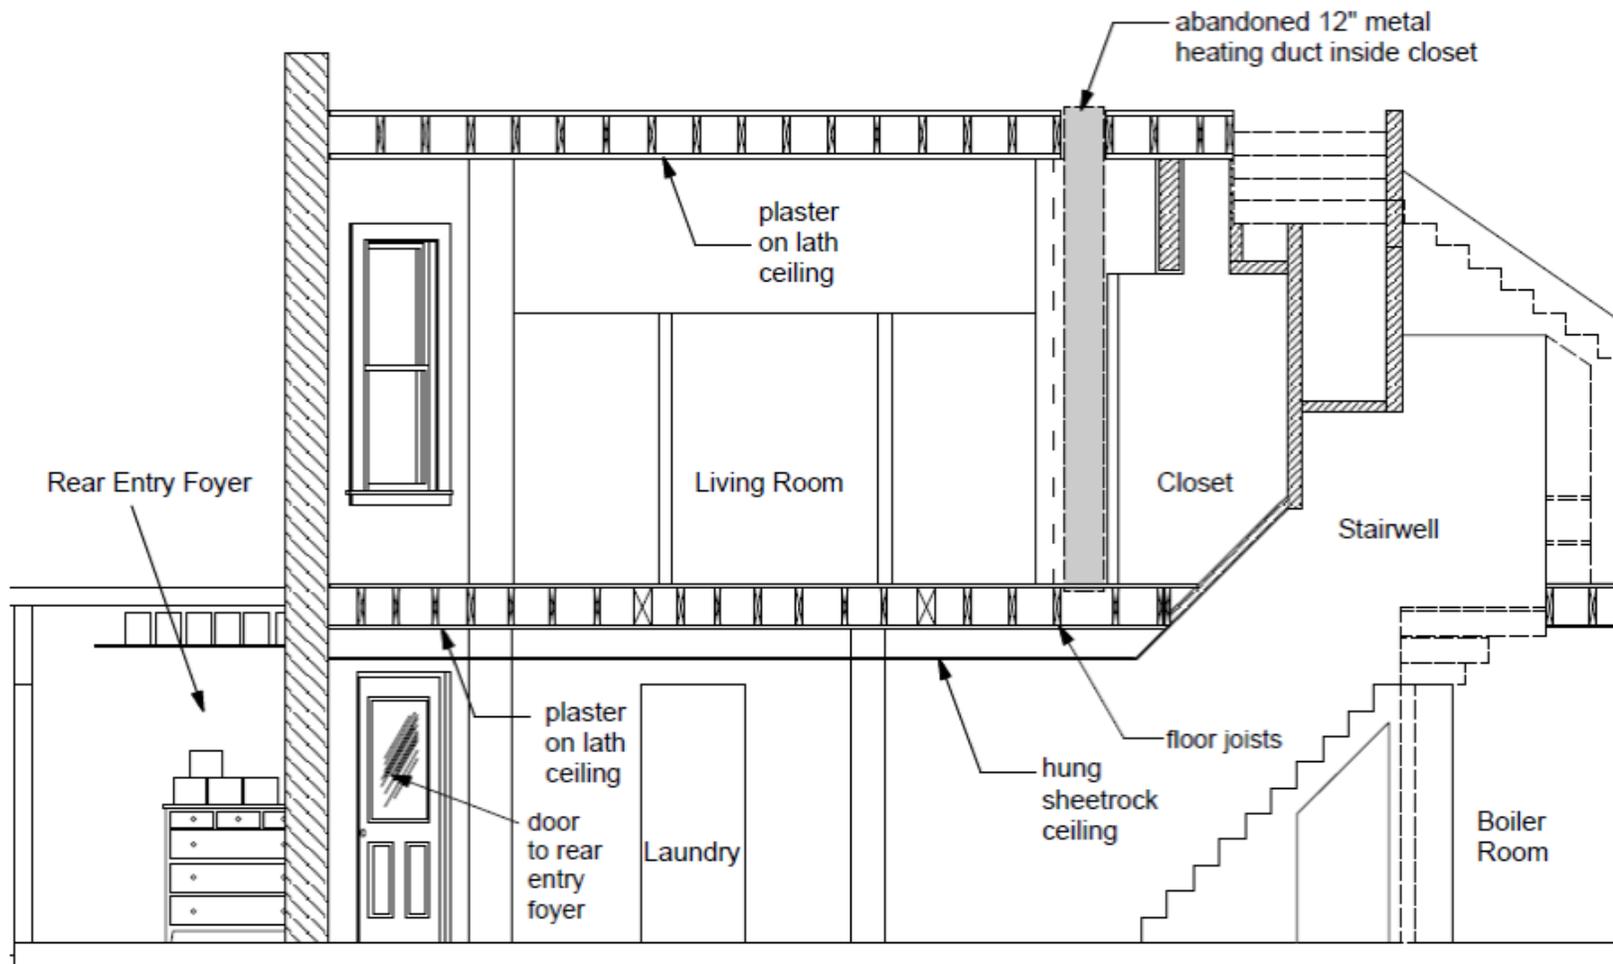
Figure IX-2. Elevation View through basement hallway looking east.

Section view detail through basement hallway looking east

The most likely explanation for the sudden fire escalation in the basement hallway and stairway is probably the failure of the hallway door window due to the glass cracking and falling out² or being blown out by pressurization of the rear entry foyer. This allowed higher flow rates of the hot gas and smoke from the rear entry foyer into the hallway and up the stairway. Another factor could be ignition of the stairway carpet caused by a few minutes exposure to the increasing radiant heat from the hot gasses flowing up the stairway. Hot combustion gases and copious amounts of smoke probably flowed into the first floor hallway by 14:50, propelling thick dark grey smoke out the front doorway as seen in Figure IX-3. The stairway carpet fire was eventually augmented by burning containers of combustible liquids on the shelves at the top of the stairway (see Figure IX-4), by the flow path up the stairway from the external winds entering the basement at the intermittently open shed (vestibule) doors and the hole burned in the rear foyer plywood wall. The stairway carpet was completely consumed by the fire.

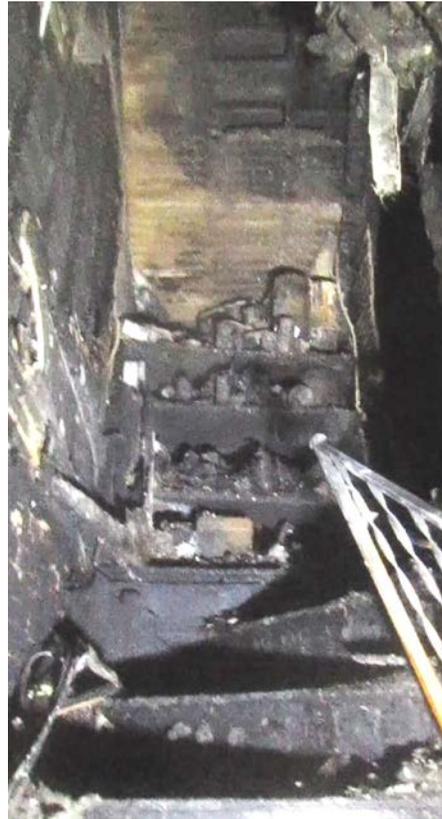
Figure IX-4. Top of the basement stairway after the fire.

LT Walsh's excited call at 14:48:48 coincided with a sudden change in fire conditions forcing firefighters on the first floor at the top of the basement stairs to quickly evacuate the building, with some retreating firefighters suffering second degree burn injuries. This sudden fire escalation motivated the Incident Commander to strike a second alarm. Based on interviews with firefighters positioned at the top of the stairs, conditions there suddenly became untenable. A sudden increase in the first floor hallway ceiling layer temperatures also caused charring of Engine 07's 2 ½ inch uncharged line of hose and melting of the nozzle's elastomeric covering in the short time it took to escape from the hallway to the front stairs twenty feet away.

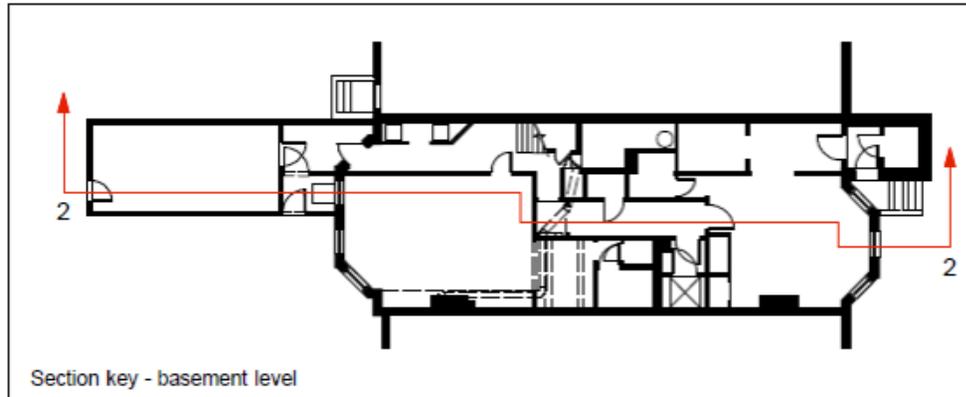
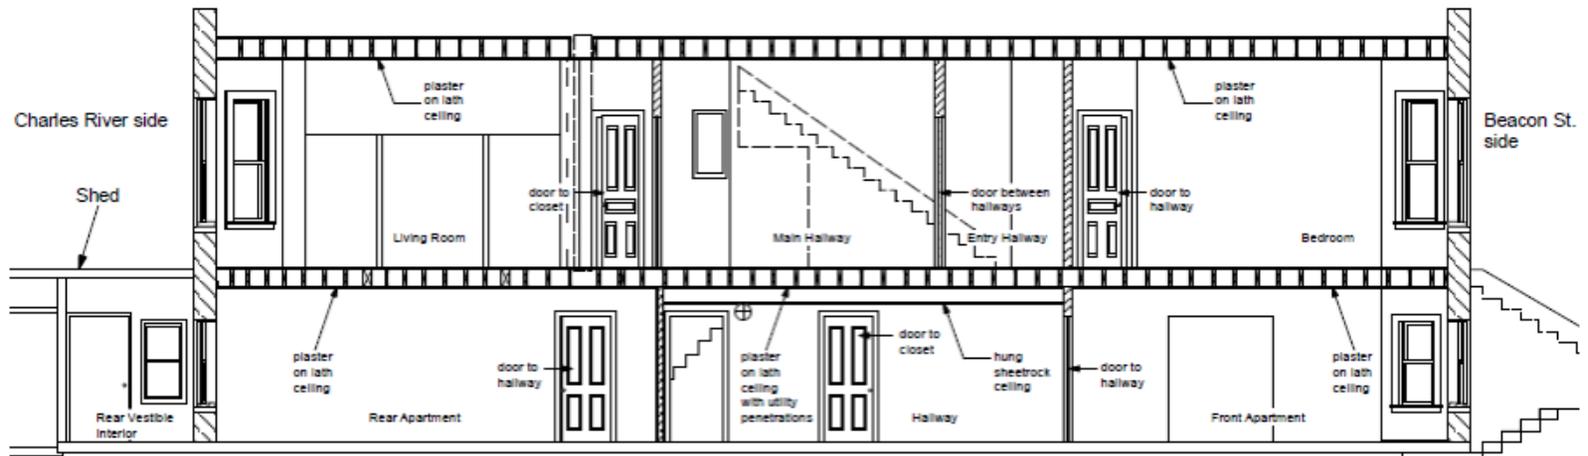
Figure IX-6. Section view 2 showing basement hallway leading to front apartment and joists above ceilings.

As indicated in the Figure IX-6 drawing, there was an approximately one foot gap between the top of the basement hallway ceiling and the bottom of the first floor floorboards, which sat on wood joists. The basement ceiling near the foot of the stairway had a penetration to allow for possible installation of plumbing piping up to the first floor apartment. This penetration allowed the hot basement ceiling layer gases to enter the gap above the ceiling and to flow to other areas above the basement. The hot combustion gases also ignited and caused extensive burning of the wood joists and electrical wiring above the ceiling as shown in Figure IX-7.

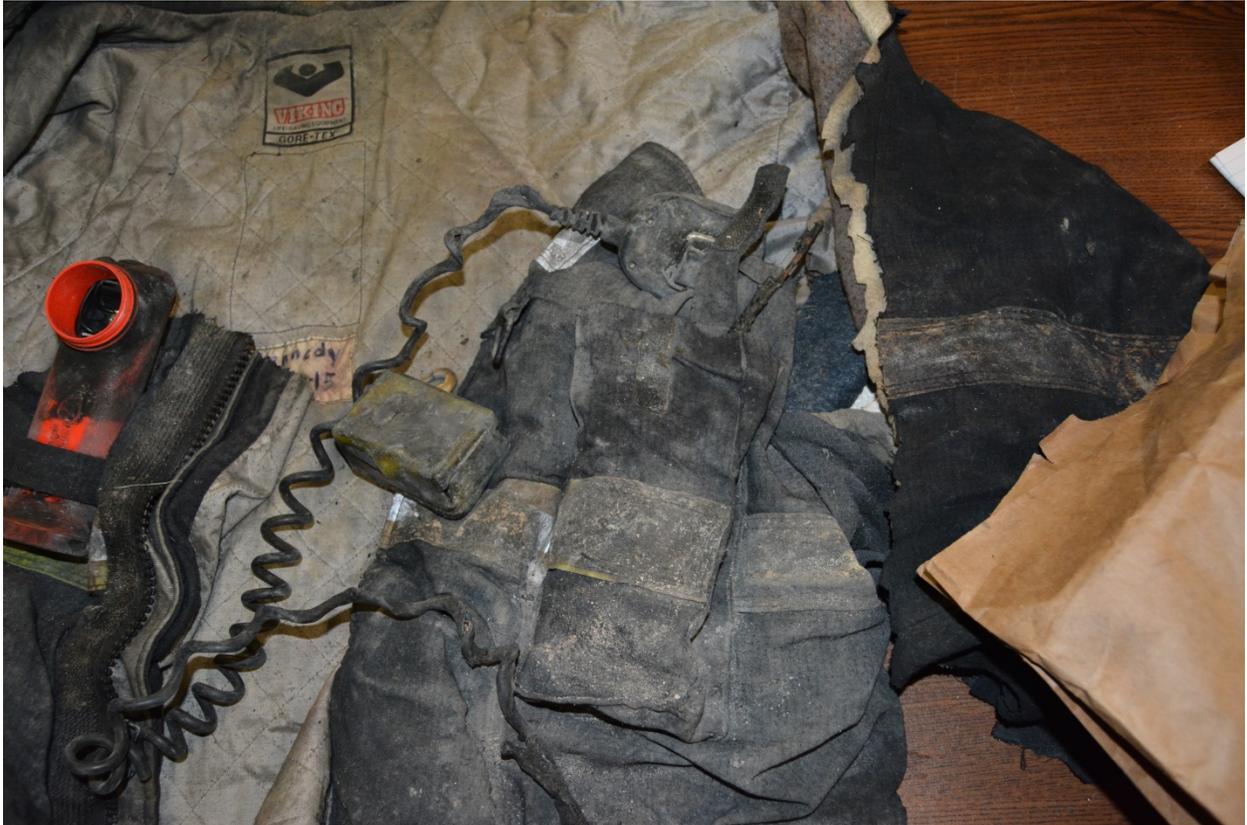
Figure XI-23. Firefighter Kennedy's Coat with Stand-Alone PASS and Flashlight

A Survivor flashlight was found to have minor thermal damage. The bezel was missing. The on/off button, when tested, still functioned properly. (Figure XI-23)

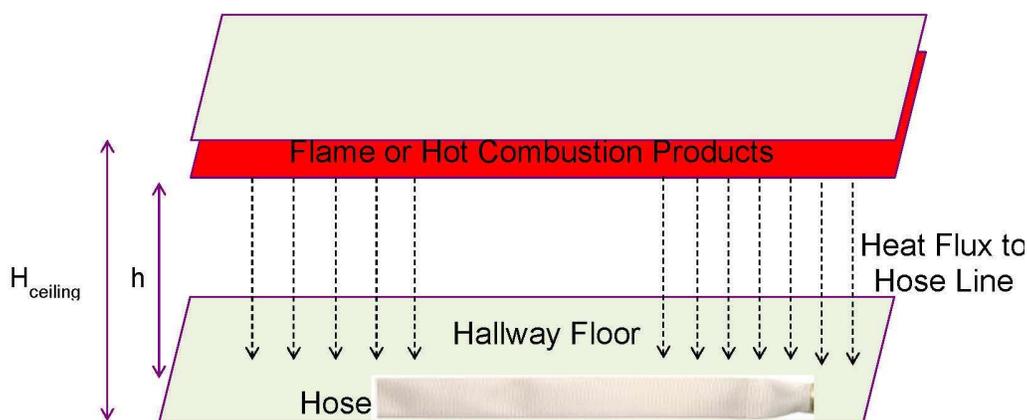
Figure XIII-1. Hose exposure to radiant heat flux from flame or combustion products under ceiling.

Radiant heat flux exposure tests were conducted on exemplar Boston Fire Department hose samples in order to determine how long a section of dry hose can withstand the radiant heat flux from a flame or hot combustion products under a ceiling. The situation is depicted schematically in Figure XIII-1. The hose is shown on the floor of a hallway, room, or stairway, and the hot gases and soot have accumulated under the ceiling such that the bottom of the hot gas layer is a distance denoted by h above the hose.

The magnitude of the radiant heat flux impinging on the hose depends on the temperature, thickness, and thermal properties of the flame or hot gas/soot layer as well as the distance h above the hose. In the case of a two-foot deep layer of combustion gas and soot from a typical residential furniture flame (temperature of 1700 °F to 1900 °F), the radiant flux at the floor would be about 9 kW/m² for a nine foot high ceiling ($h = 7$ ft), and about 20 kW/m² for a seven foot high ceiling ($h = 5$ ft). In the case of a three foot deep flame under the nine foot high ceiling ($h = 6$ ft), the radiant flux at the floor would be about 15 kW/m².

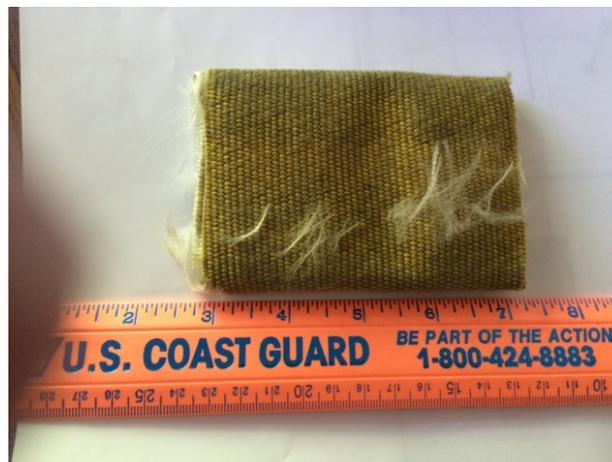
Figure XIII-3. Section of fire hose used in cone calorimeter tests.

Tests in the Worcester Polytechnic Institute (WPI) cone calorimeter were conducted using hose samples representative of the 1 3/4 inch attack hose used by Engine 33. Per the December 2013 BFD Attack Hose Specifications, the inner and outer hose jackets are made of filament polyester yarn. The waterway is a synthetic rubber. Figure XIII-3 shows one of the 4-inch sections of hose cut for use in the WPI cone calorimeter.

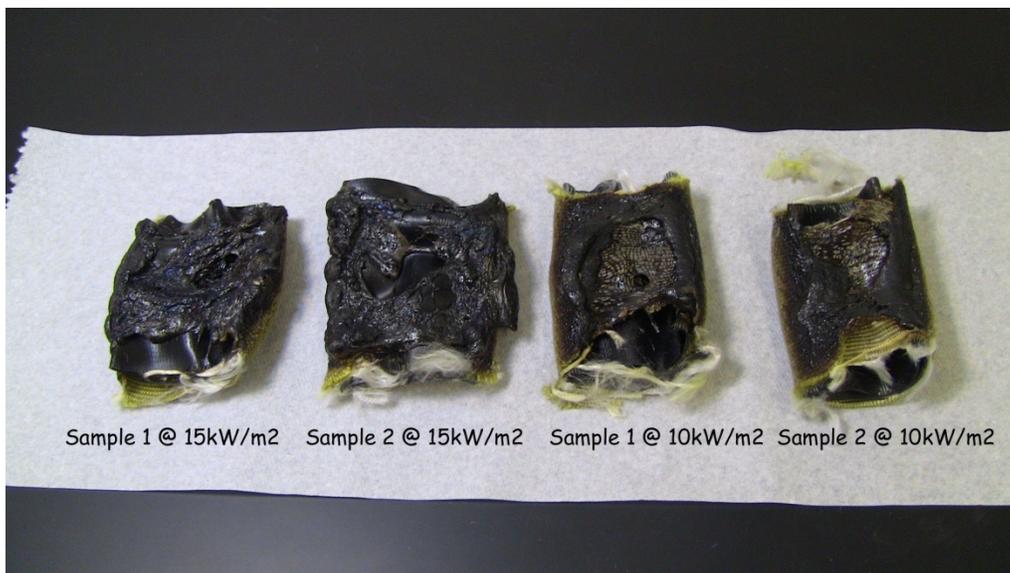
Results are shown in Table XIII-1. Melting of the jackets occurred after about two minutes of exposure to the 15 kW/m² heat flux, and after about four minutes of exposure to the 10 kW/m² heat flux. Smoking and charring of the hose, indicating the initial degradation of hose strength and high pressure water carrying capability, occurred 20 to 30 seconds prior to the actual melting of the hose samples.

Figure XIII-4 is a photograph of the charred and melted hose samples after the heat flux exposure tests.

Figure XIII-4 Hose samples after radiant heat flux exposure tests.

5. Provide input and support for the promulgation of improved thermal resistance testing by the NFPA in conjunction with the testing agencies and hose manufacturers. When approved by the NFPA, the Department should replace existing attack hose with hose meeting the latest standards.

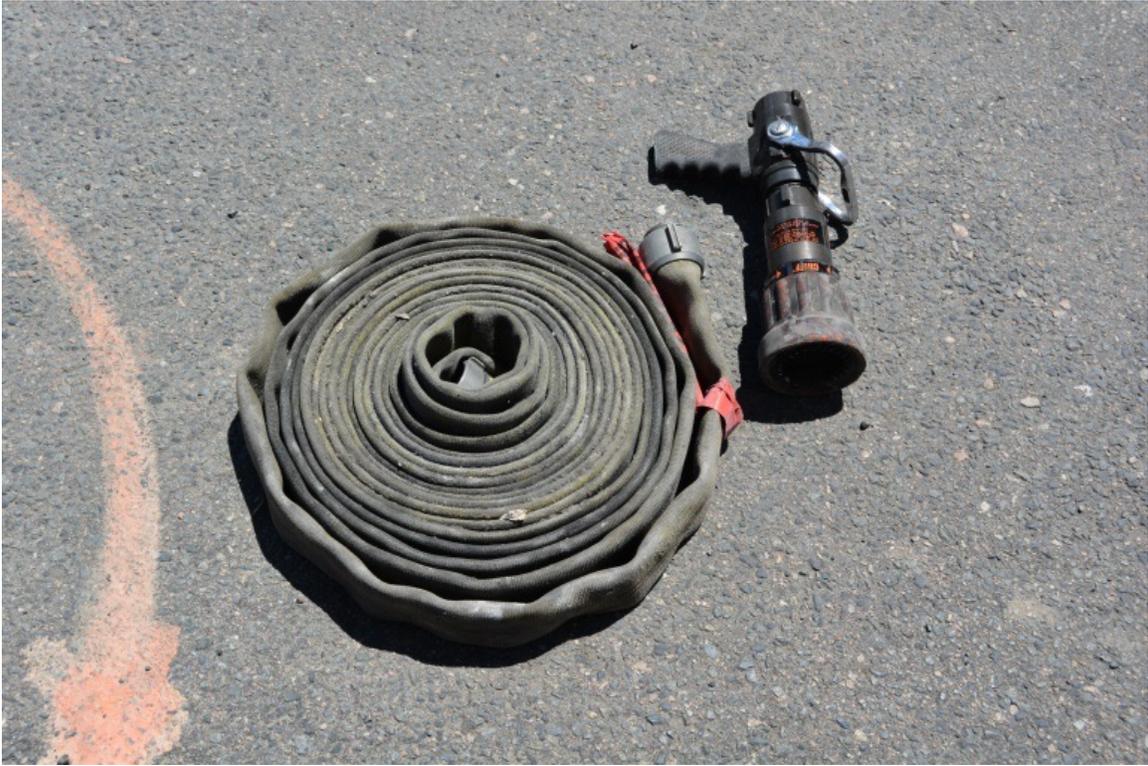
The test of Engine 33's hose and nozzle combination produced a flow rate that exceeded the manufacturer's specifications as well as E24's newer comparison hose and nozzle combination. Based on these tests, it is the Board's opinion that neither a malfunction nor deficiency in the flow rate of E33's Elkhart Chief low pressure nozzle occurred. It is the Board's finding that E33's assigned 1 ¼ inch nozzle would not have negatively impacted E33's ability to provide an adequate stream at the rated flow rate.

Engine 33's fifty-foot Mercedes 1 3/4 inch hose with Elkhart Chief nozzle

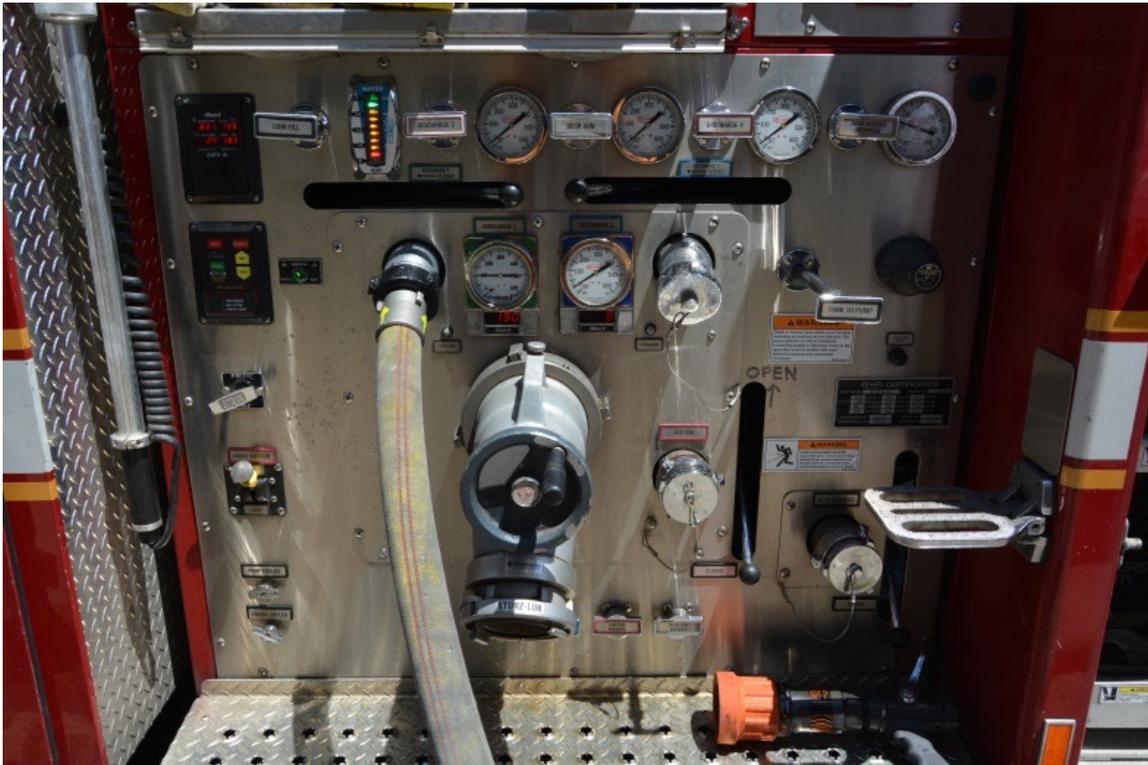
Flowing 190 GPM at 100 PSI

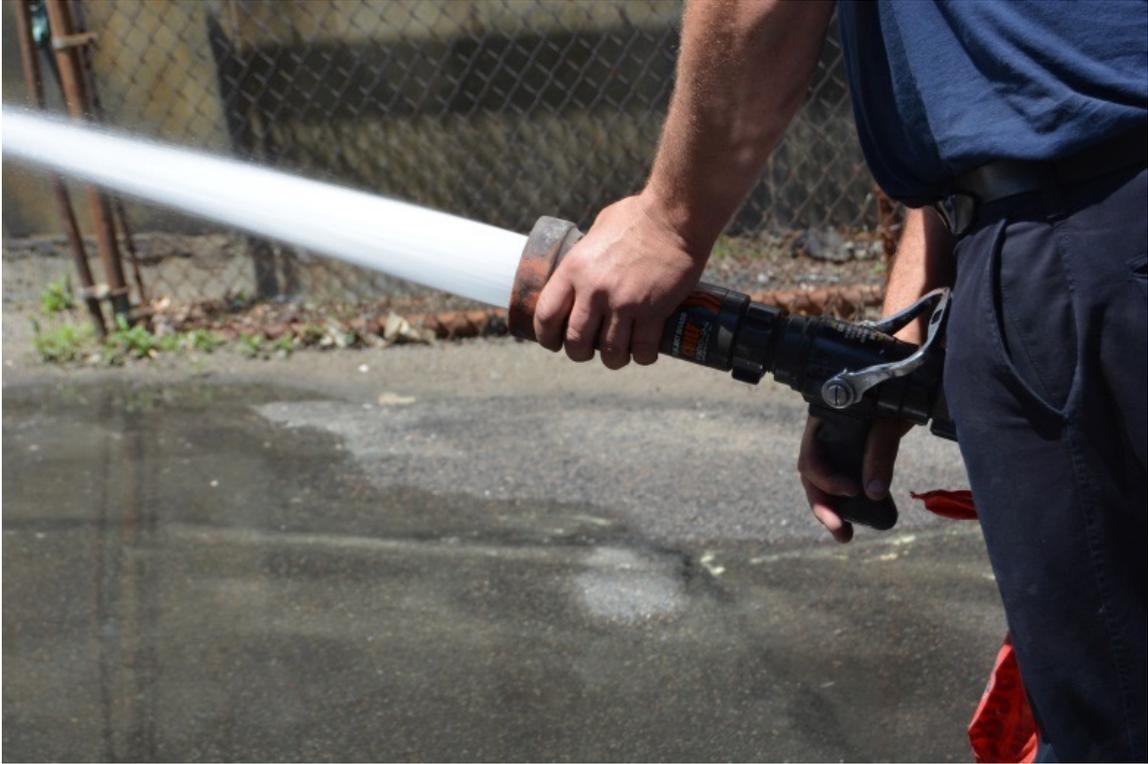
Straight stream flowing 190 GPM at 100 PSI

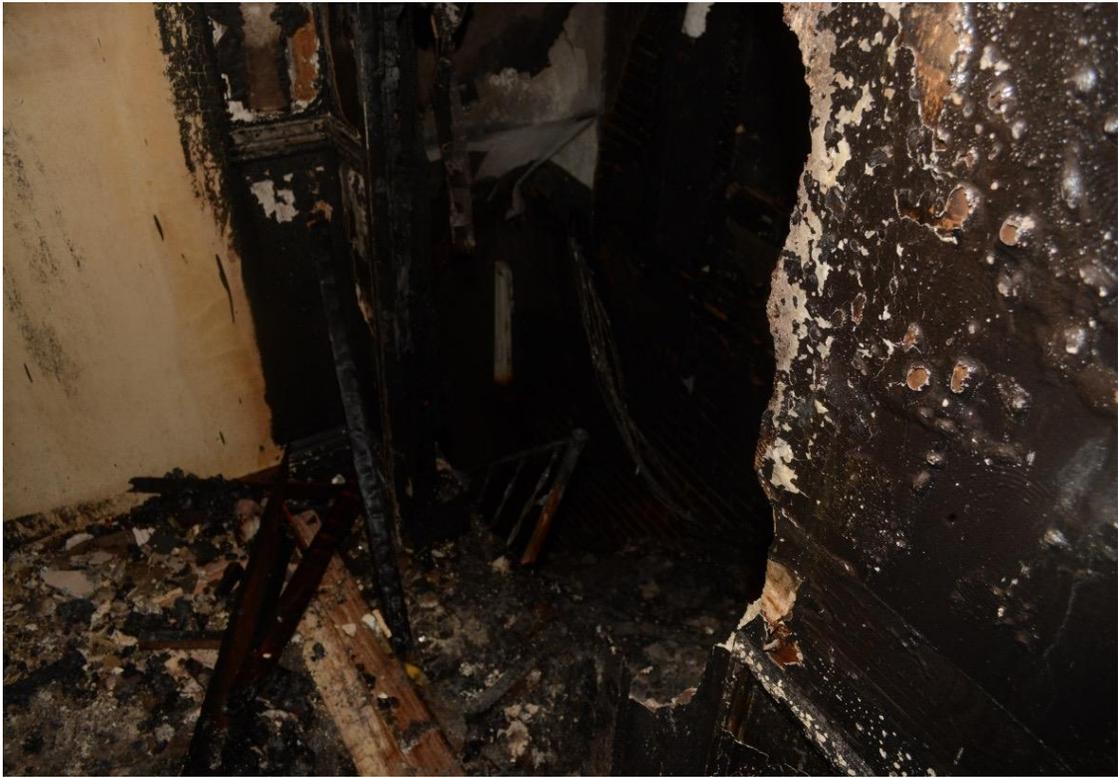
Figure XV-4 Top of the basement stairway where E33's hose line breached.

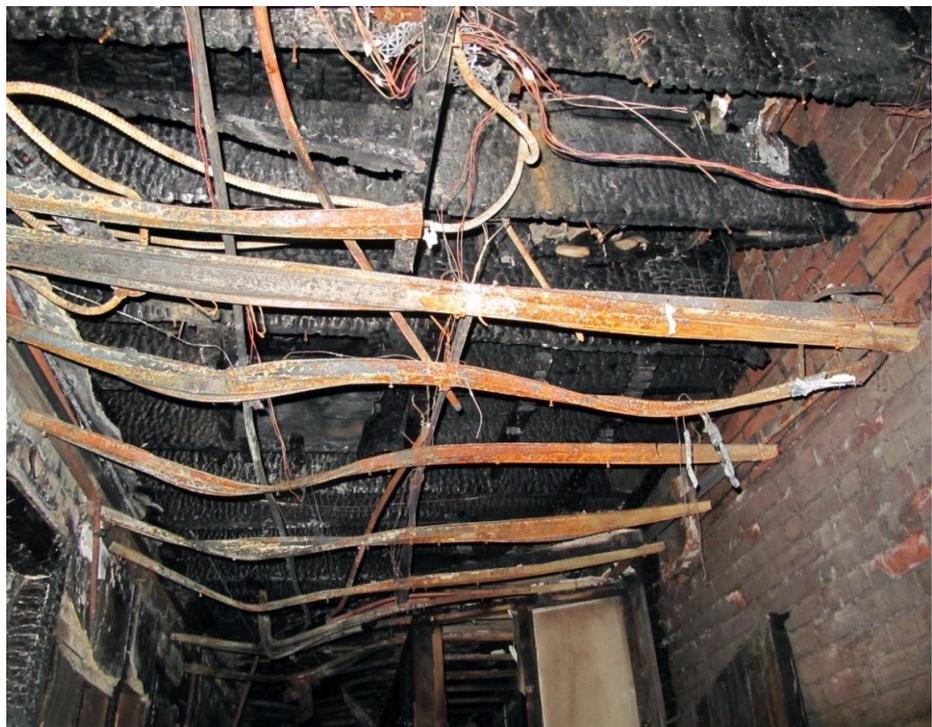
Figure XV-12 The suspended ceiling framework at the bottom of the stairway exposing heavily charred floor joists and the shaft opening.

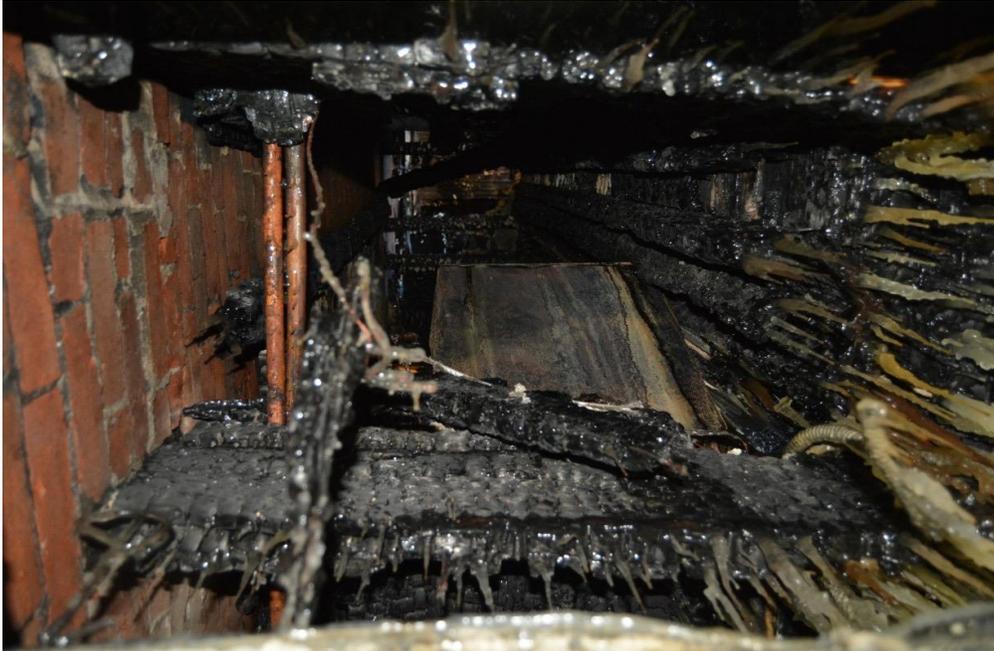
Figure XV-13 The open shaft at the foot of the basement stairway, previously hidden by the suspended ceiling. The shaft was a conduit for fire and gas extension to the second floor.

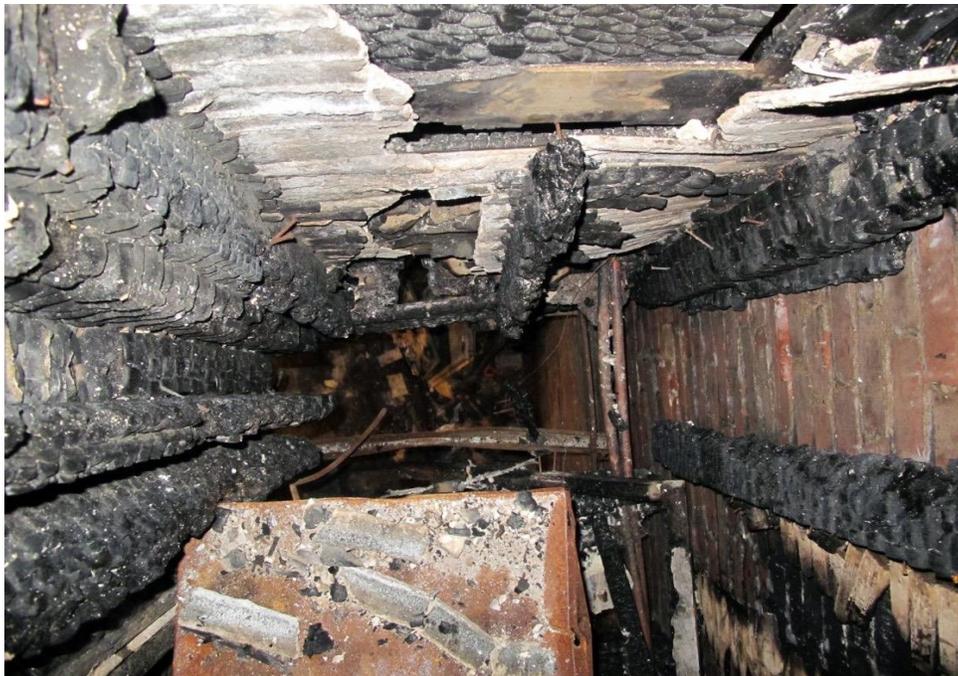
Figure XV-14 The shaft viewed from the second floor looking toward the basement.

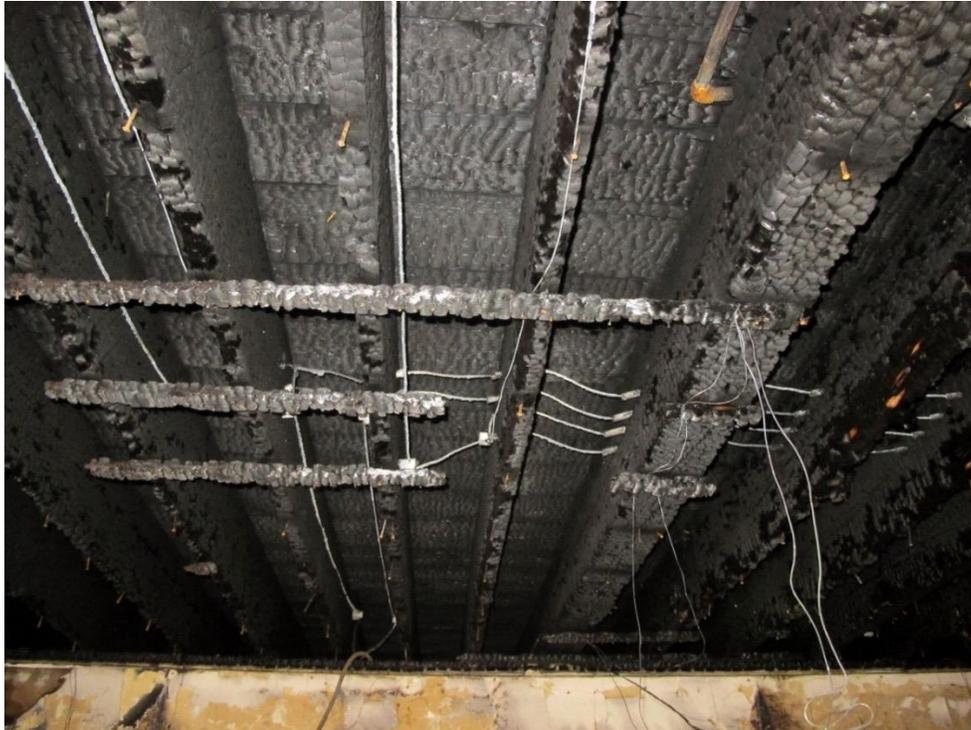
Figure XV-17 The open joist bays extending over the demising wall between the basement hallway and the rear apartment.

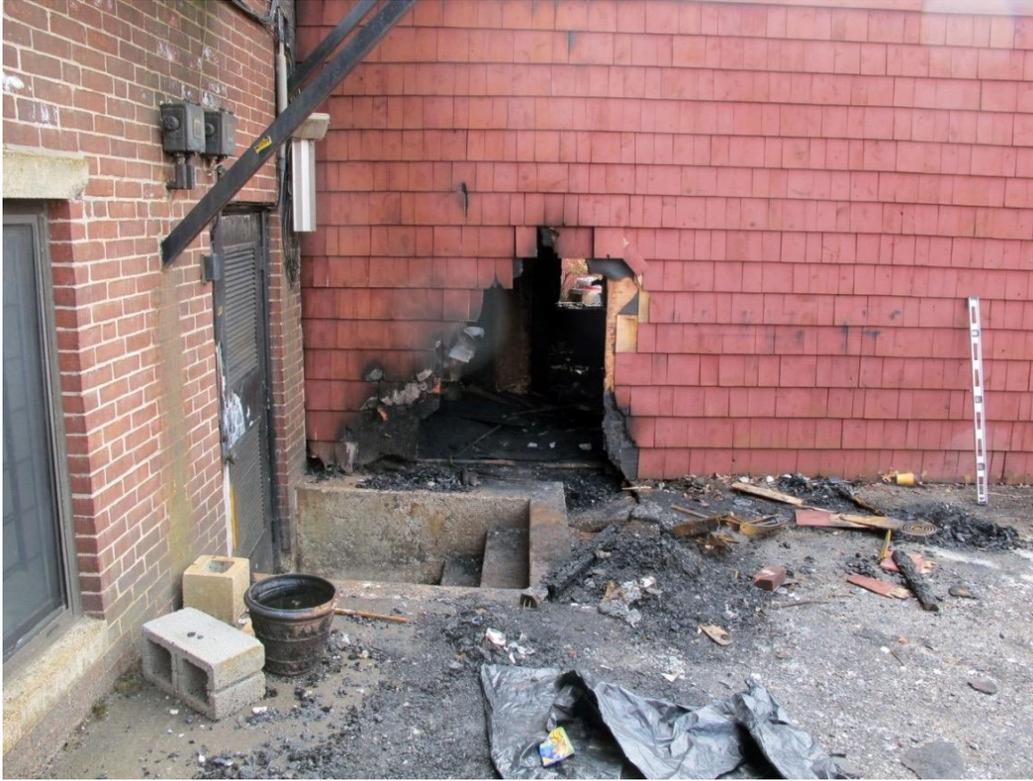
Figure XV-19 Area of origin on the exterior of the shed.

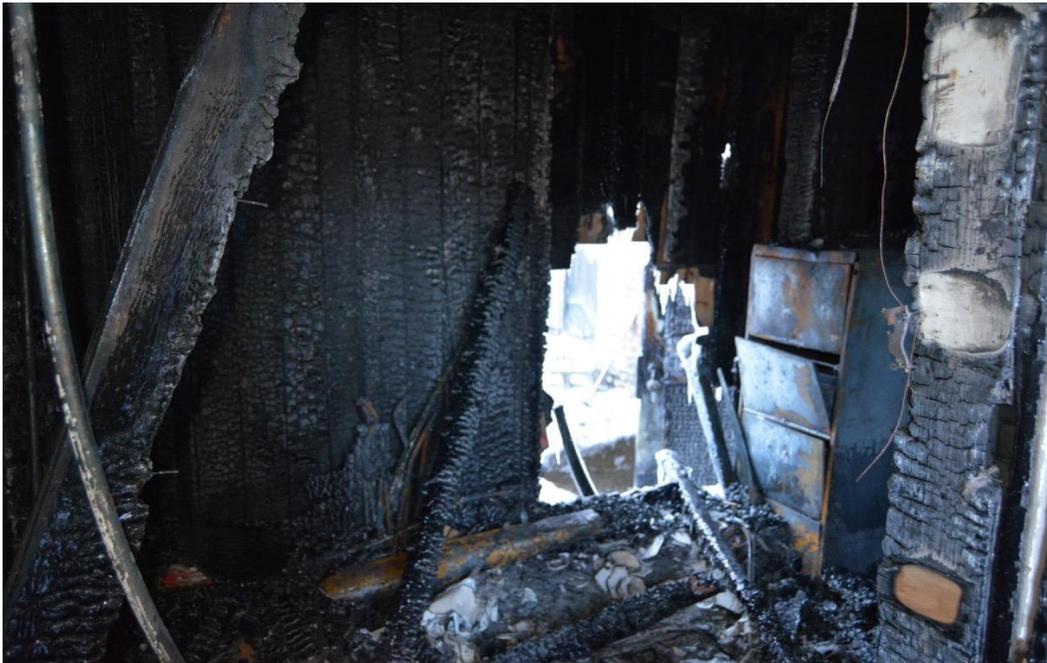
Figure XV-20 Interior view of the shed entrance foyer, where fire breached the shed siding.

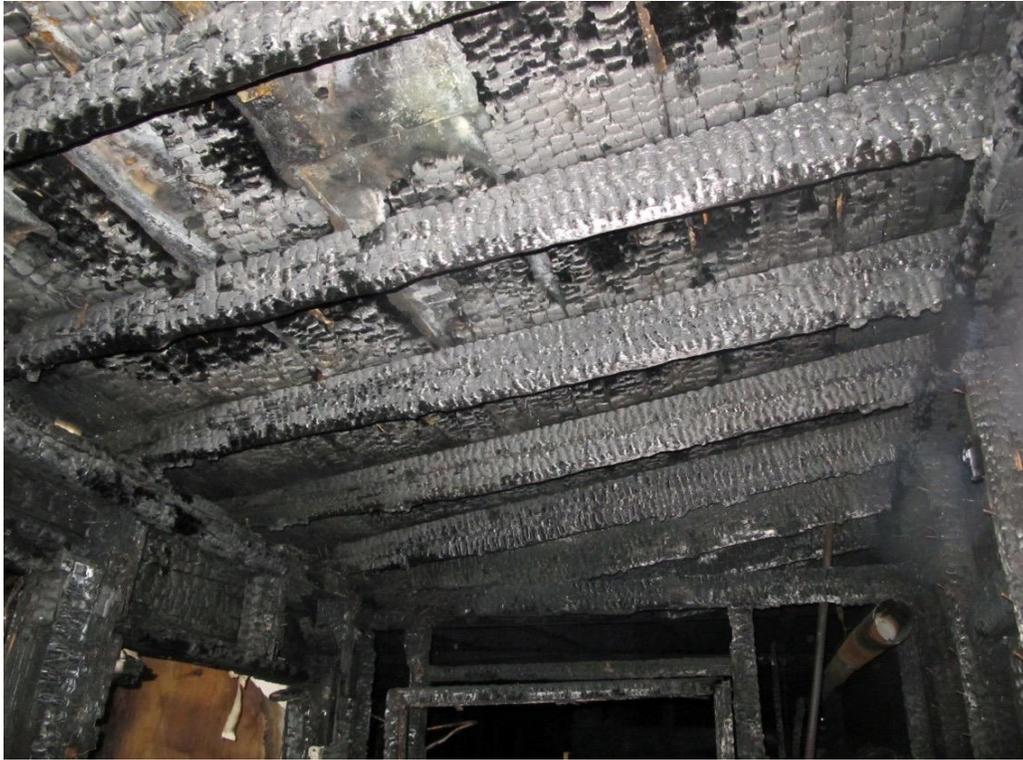
Figure XV-21 Heavily charred unprotected rafters in the shed entrance foyer.

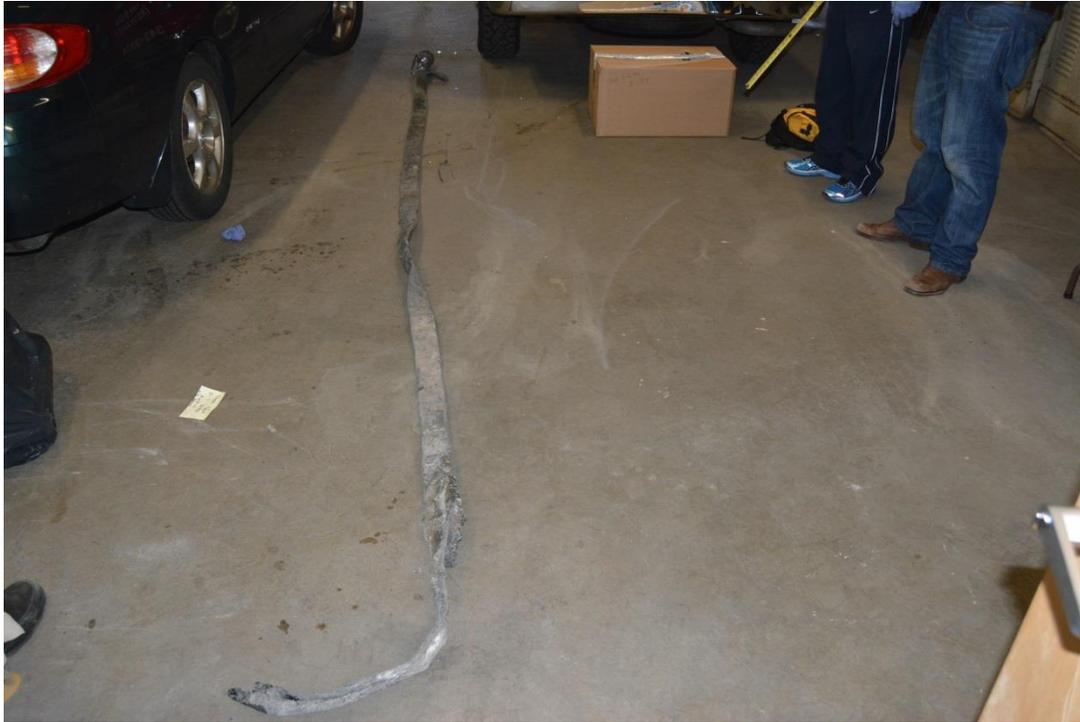
Figure XV-25 Segment of E33's line of hose and nozzle recovered within the apartment.

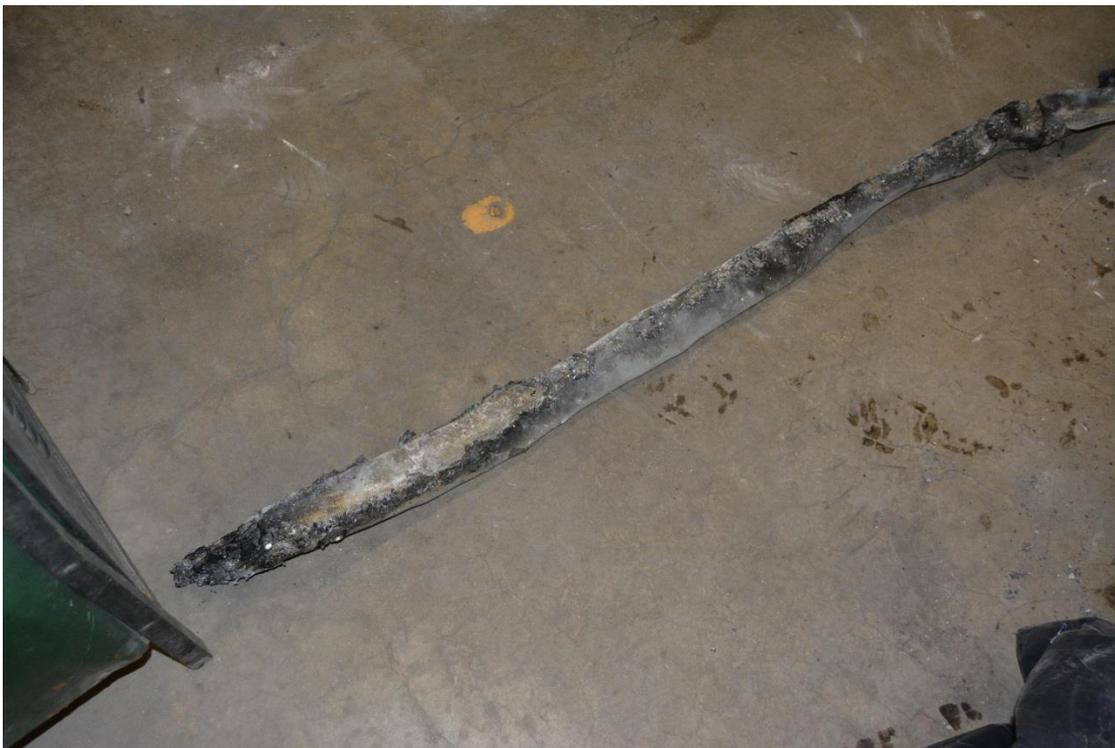
Figure XV-26 E33's line of hose where it separated entering the apartment from the hallway. There were no remnants of the hose from the top of the stairs to the apartment.
