# Mission Church Complex

## Study Report

Report on the Potential Designation of

**MISSION CHURCH COMPLEX**  
**1545 Tremont Street, Roxbury, Massachusetts**

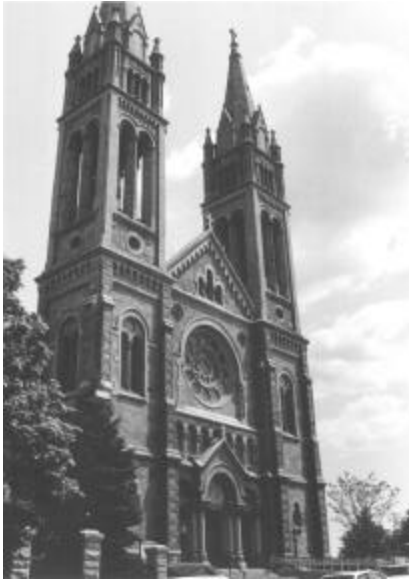
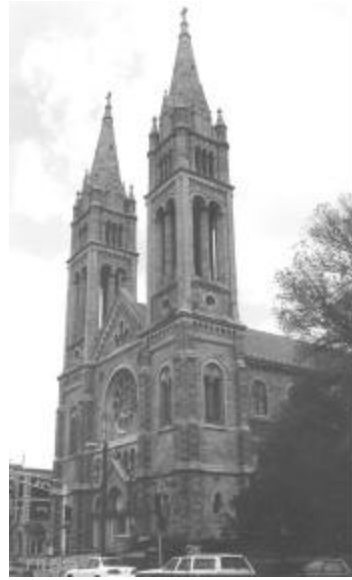
Front façade of the basilica

The central bay, on axis with the altar, reflects the prominence of its position. A tripartite arrangement of Romanesque arches serves as the main entry into the basilica. An elaborately carved tympanum depicting Mary and Jesus surrounded by angels distinguishes the central entry. A variation on quatrefoil windows flanked by small oculi, and glazed with stained glass pierce the masonry tympanums to either side of the main entry. Decorative, wrought iron hinges embellish the board and batten oak entrance doors. Two quatrefoil transom lights carved into oak panels above each of the secondary entries illuminate the narthex. These too are glazed with stained glass. Above the central entry, a granite-faced gable capped with a small granite cross at its apex interrupts the granite string course that demarcates the second floor of the narthex. A granite blind arcade that runs the width of the bay rests on the floor-level stringcourse. Granite crests flank a recessed rose window that dominates the second story height of the central bay. A gable pierced by tripartite fenestration, embellished by a corbelled cornice, and at its apex, a small granite cross, crowns the central bay.

Subordinate to the central bay, the facades of the flanking bays are significantly less embellished. A single, small Romanesque arched window trimmed with granite and framed by slightly recessed, attached, squat columns pierces each ground floor level. These windows are glazed with stained glass. At the second story height, each bay features a large Romanesque arched window, trimmed with granite. Recessed from the wall plane, two smaller, round arched openings within the larger Romanesque openings are divided by an attached column, and surmounted by an oculus. Leaded, diamond panes glaze these windows. A small, denticulated course runs beneath the corbeled cornice on each bay. The fenestration and ornamentation is repeated on all facades of the towers.

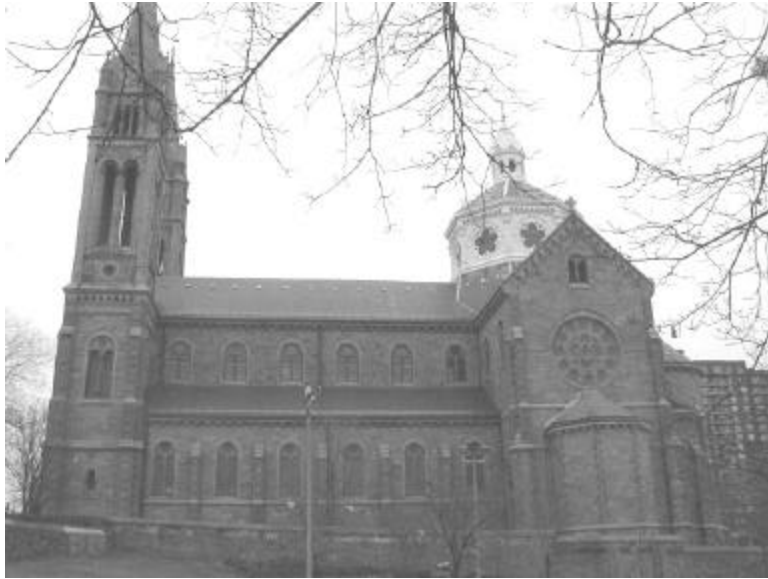
East façade of the basilica

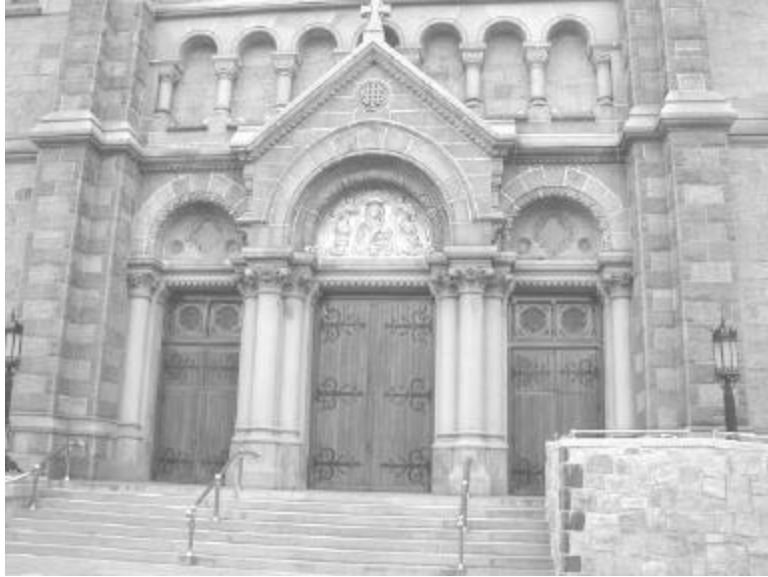
Main entrance to the basilica

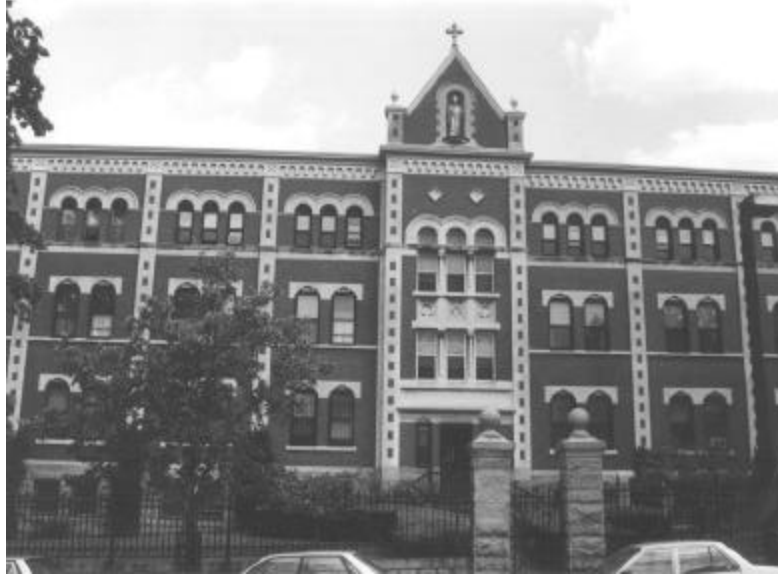
Front façade of the rectory (Tremont Street)

of red brick, limestone trim and basement level granite facing highlight fenestration, articulate bays, and define an elaborate cornice. This decorative treatment is most concentrated around the projecting, central entrance bay of the main facade. A gable front rising above the mass of the building further distinguishes this prominent bay. The founder of the Redemptorist order, St. Alphonsus, is celebrated at this height in a limestone-trimmed niche at the center of the gable. Two acorn finials at its side, and a cross at its apex frame the gable. Entry to the building is through an eight-paneled oak door in the central projecting bay.

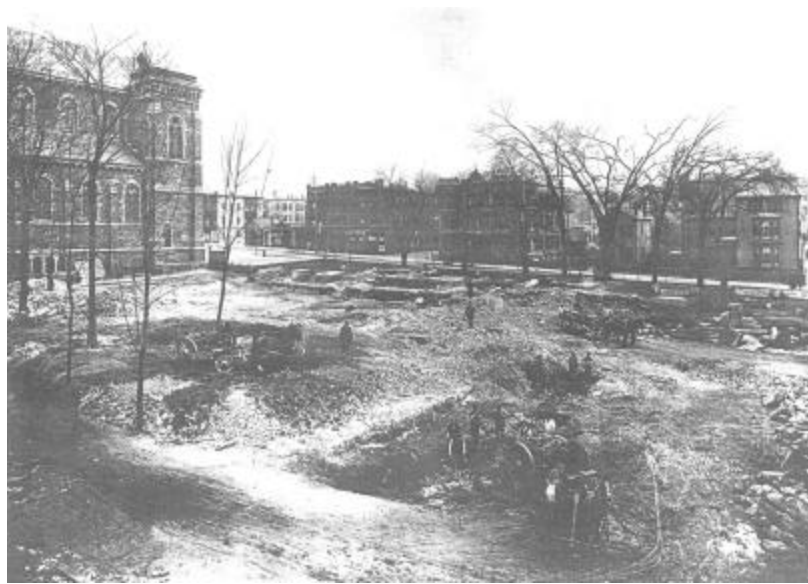
Construction of the rectory building

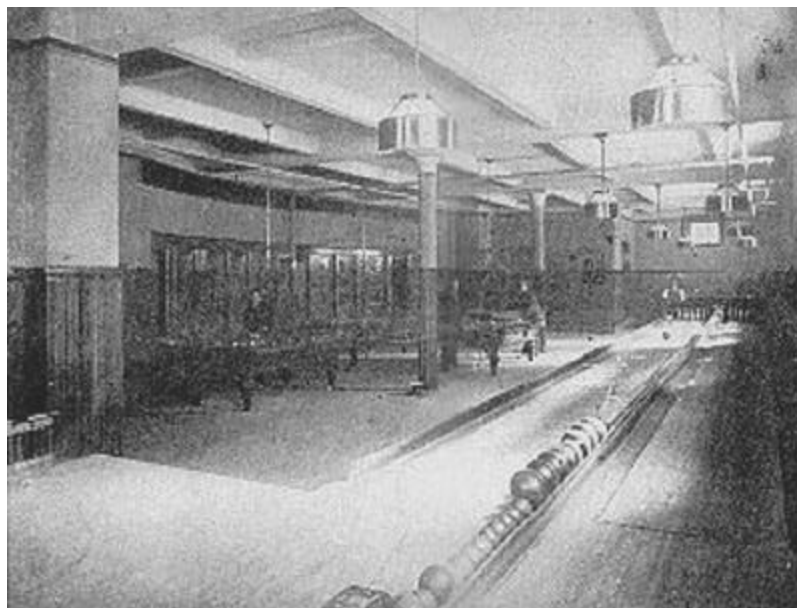
Bowling alley and billiard tables in St. Alphonsus Hall
